Sterling Highway MP 45-60 Accident Analysis

**State of Alaska
Department of Transportation and
Public Facilities**

**HDR Alaska, Inc.
2525 C Street, Suite 305
Anchorage, Alaska 99503**

March 2006

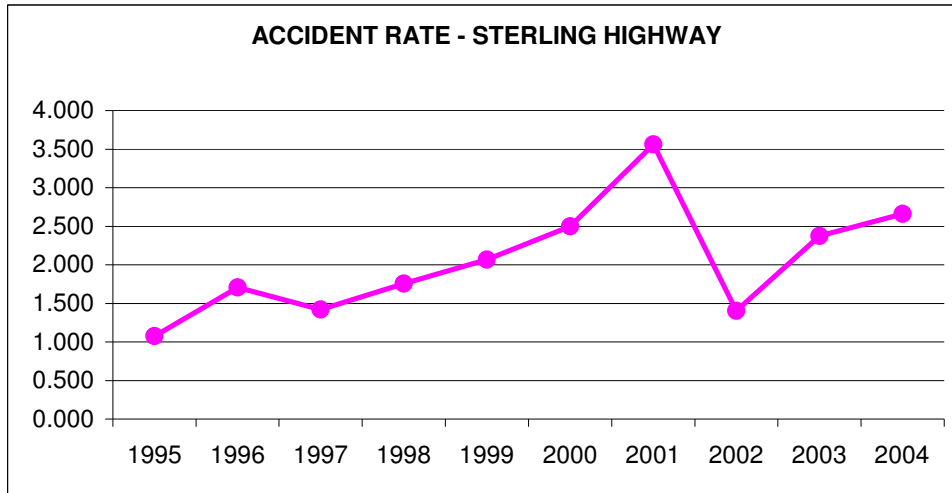
Figure 1

The accident rate along the Sterling Highway from Quartz Creek Road to Skilak Lake Road nearly doubled between 1995–2004 or at an annual rate of 14.7 percent. In 2001, the accident

rate peaked to a data record high of 52 accidents and dropped considerably to 22 accidents and has increased steadily since 2002 (Figure 1).

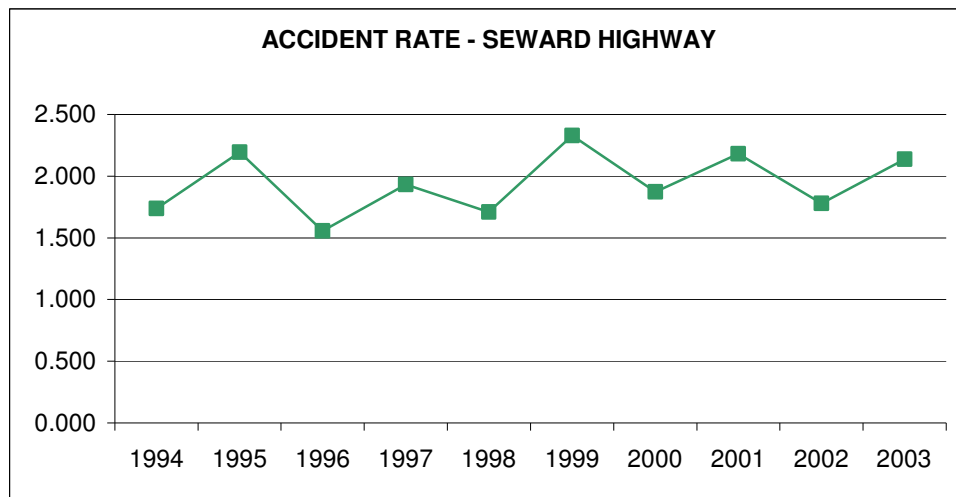
Figure 2

The accident rate along the Seward Highway from MP 73 to 90 never dropped below a rate of 1.5 and rose and fell through a consistent cycle from 1995–2003. During this time period, the accident rate increased at an annual rate of 2.3 percent (Figure 2).

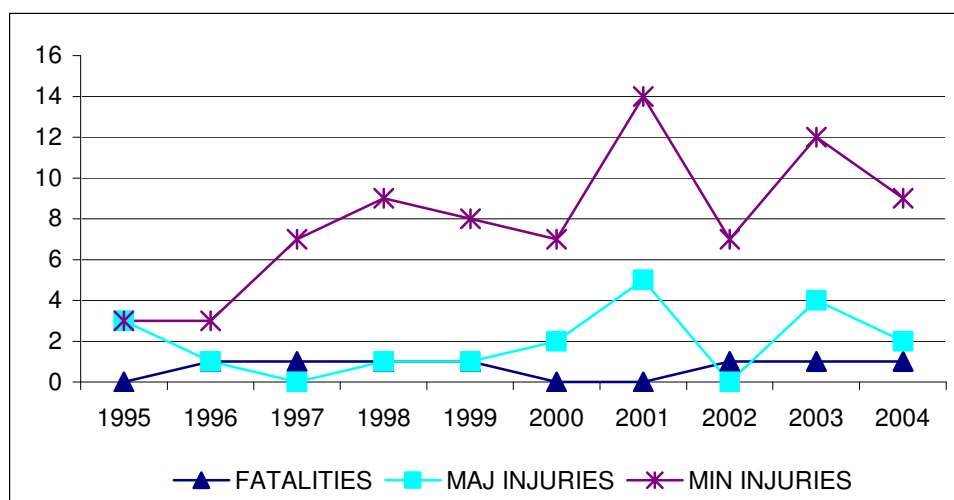
Figure 3: Accident Severity

As illustrated below in Figure 3, the amount of fatalities over the ten year period has stayed consistent at zero or one fatality each year from 1995–2004. Major injuries have fluctuated over the same time period peaking in 2001 as the amount of minor injuries has reflected the same pattern.
