**ROUTINE WETLAND DETERMINATION  
(1987 COE Wetlands Delineation Manual)**

Project/Site: Sterling Highway Project MP 45 - 60	Date	9-15-03
Applicant / Owner: ADOT&PF	Borough	KPB
Investigators: JDS & AA	State	AK
Do Normal Circumstances exist on the site? <input checked="" type="checkbox"/> YES <input type="checkbox"/> NO	Community ID	Sedge meadow
Is the site significantly disturbed (Atypical Situation)? <input type="checkbox"/> YES <input checked="" type="checkbox"/> NO	Transect ID	-
Is the area a potential Problem Area? (If needed, explain on reverse) <input type="checkbox"/> YES <input checked="" type="checkbox"/> NO	Plot ID	Plot 21

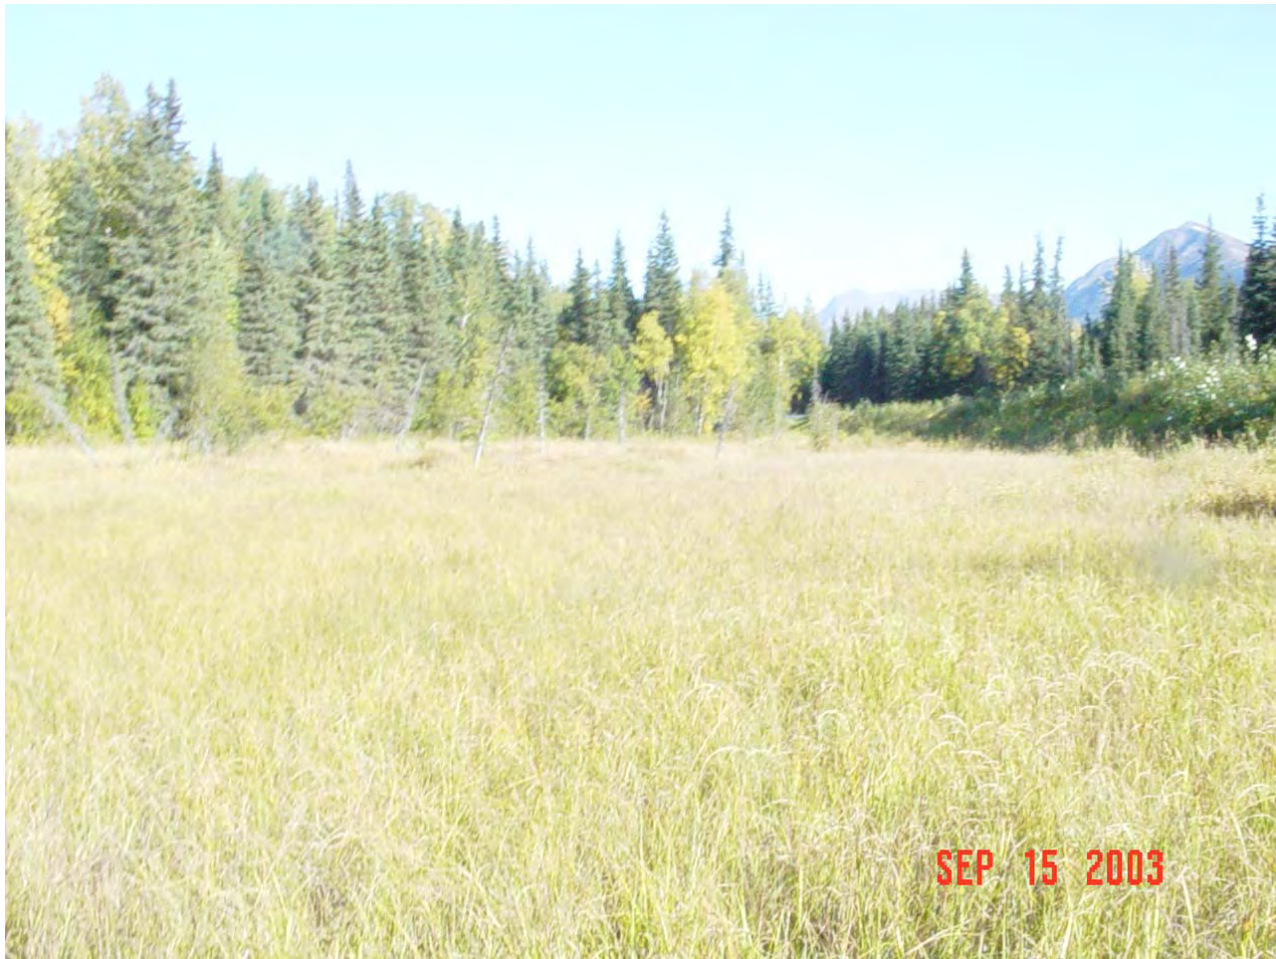
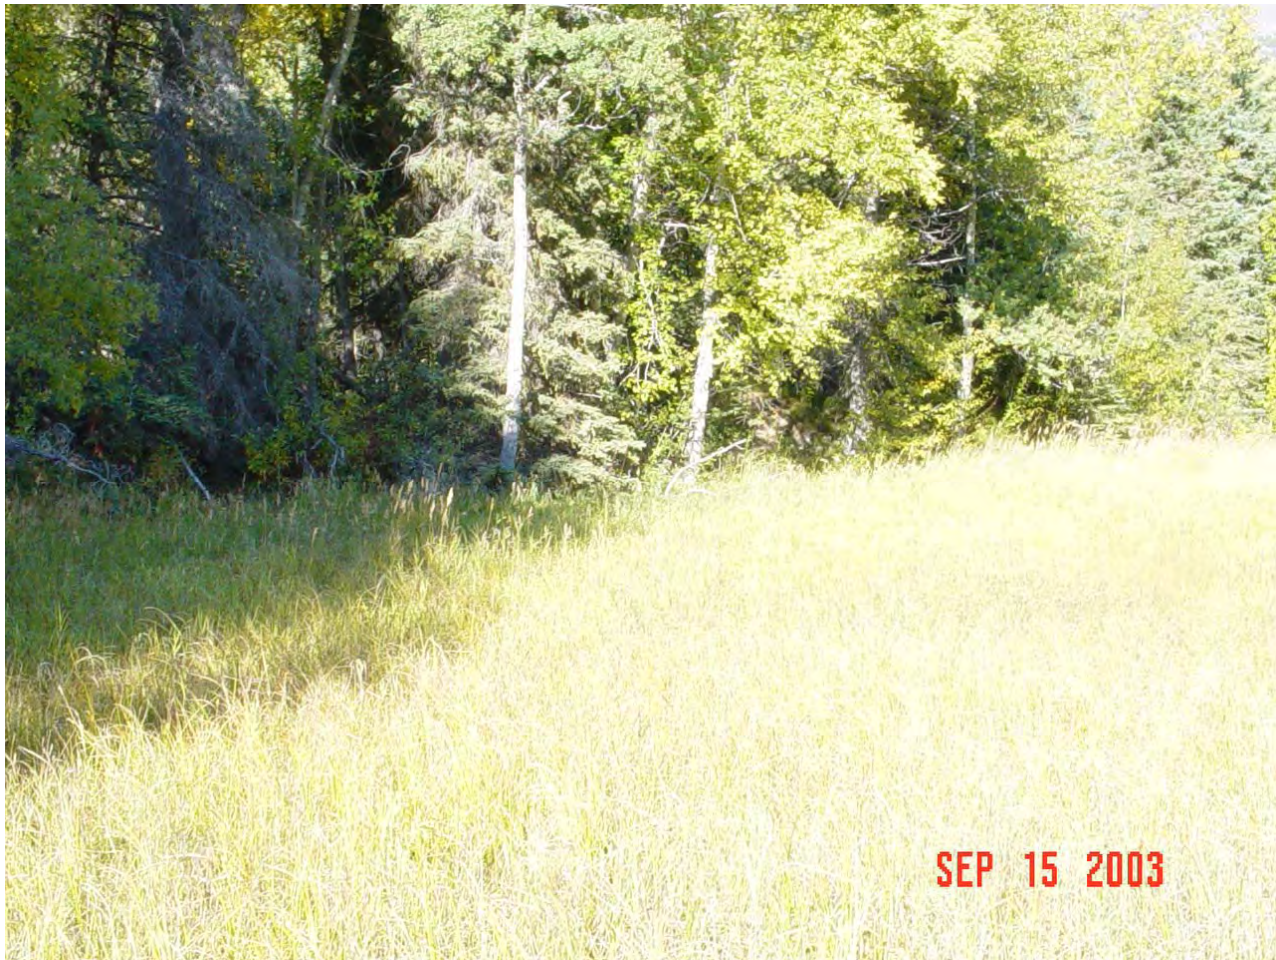
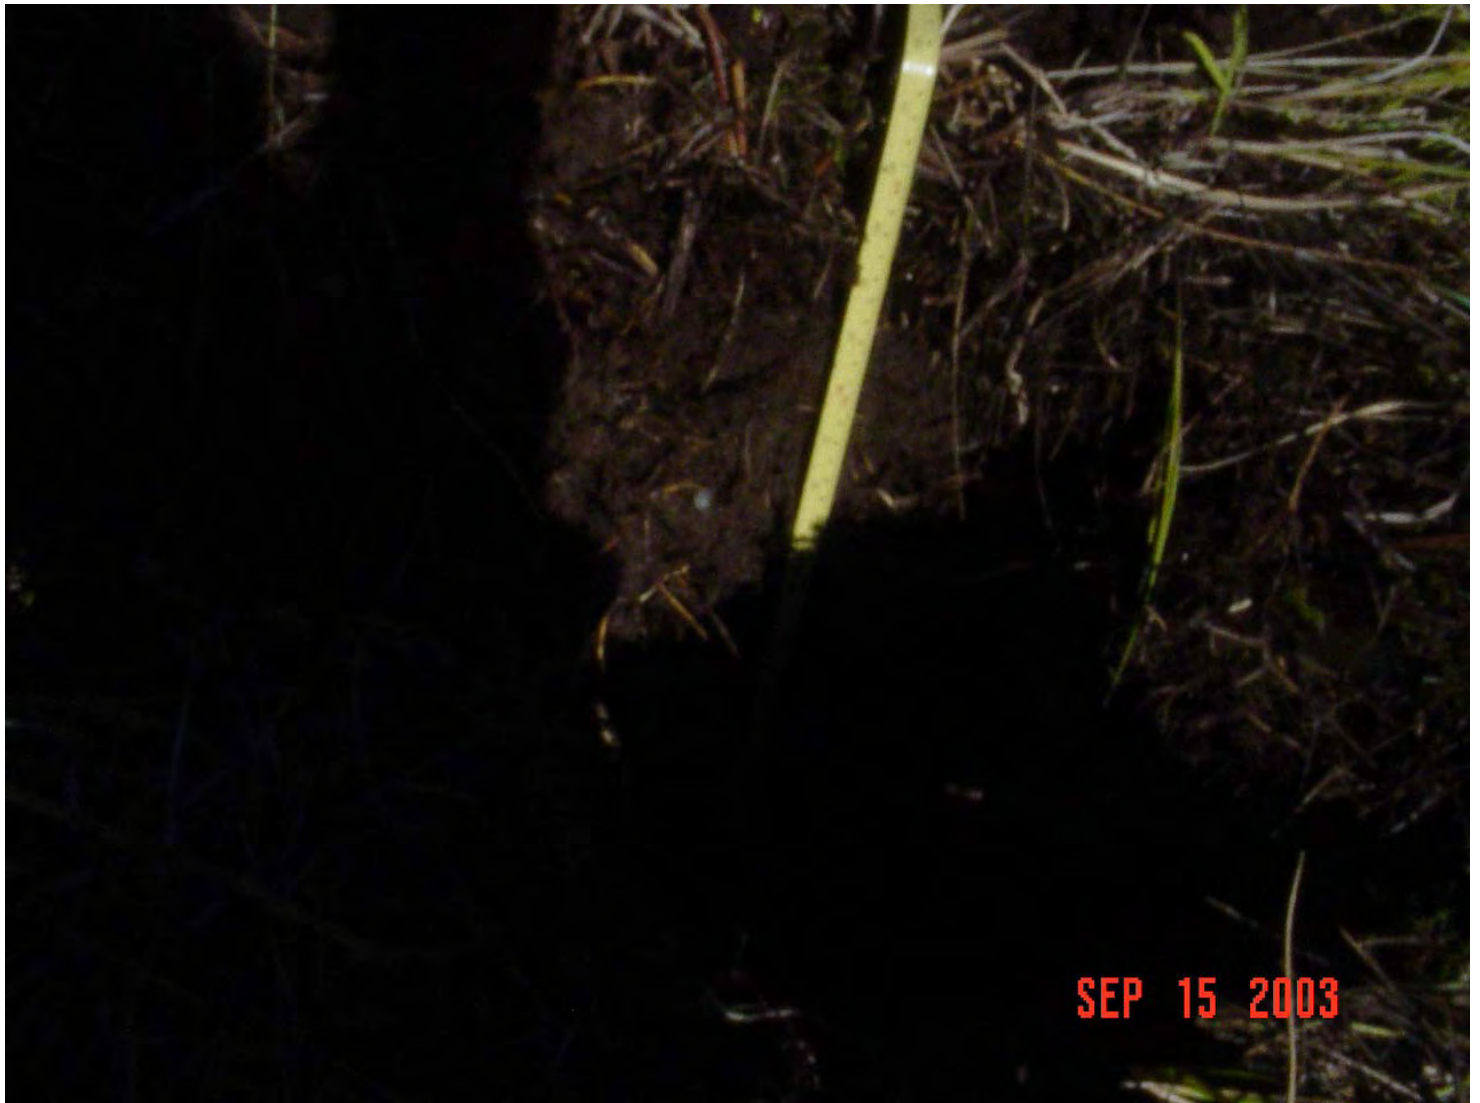
Site: Plot 21

Describe Vegetation Type: sedge meadow. Willow and horsetails on mounds of higher ground.

Remarks: Many areas present that had contained standing water in past (dry upon field investigation)

<input type="checkbox"/> Gleyed or Low-Chroma Colors		<input type="checkbox"/> Other (Explain in Remarks)			
Remarks: There were some small chunks of mineral soil mixed in with histosol. Color = g14/N					
Major root zone: upper 16"

NWI Class: PEM1C

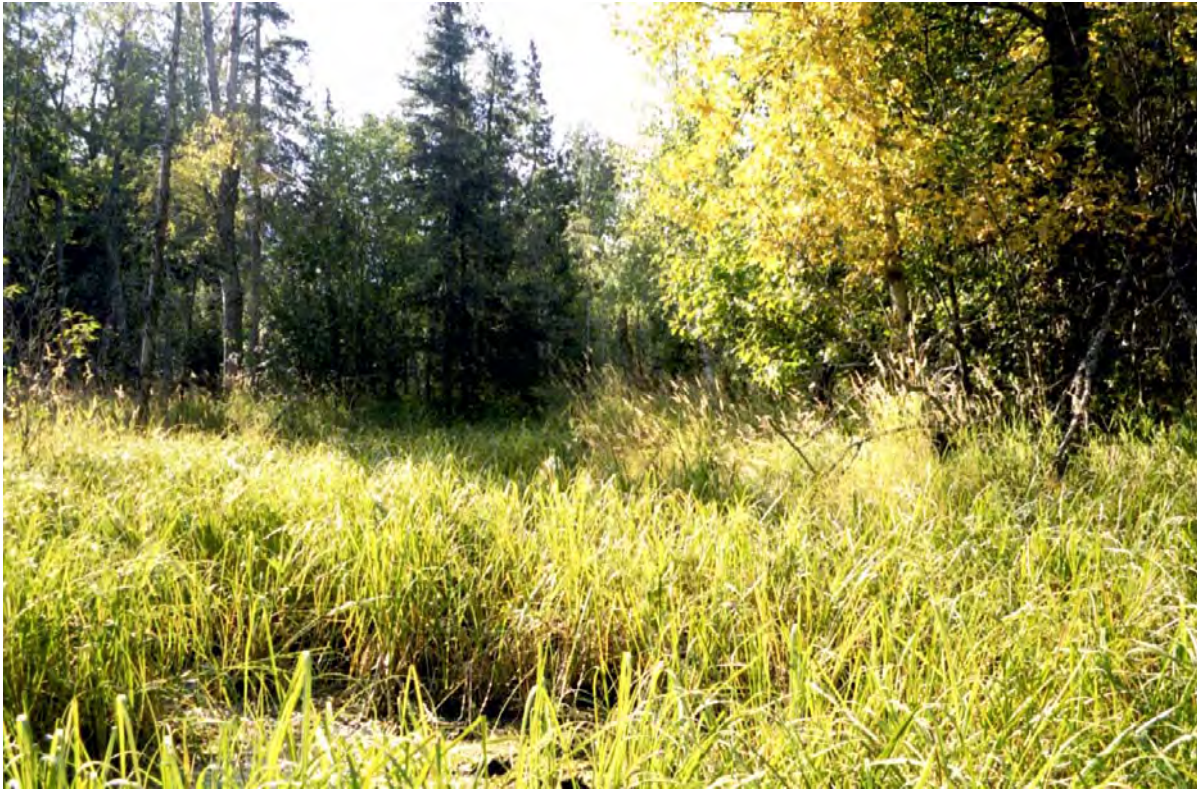
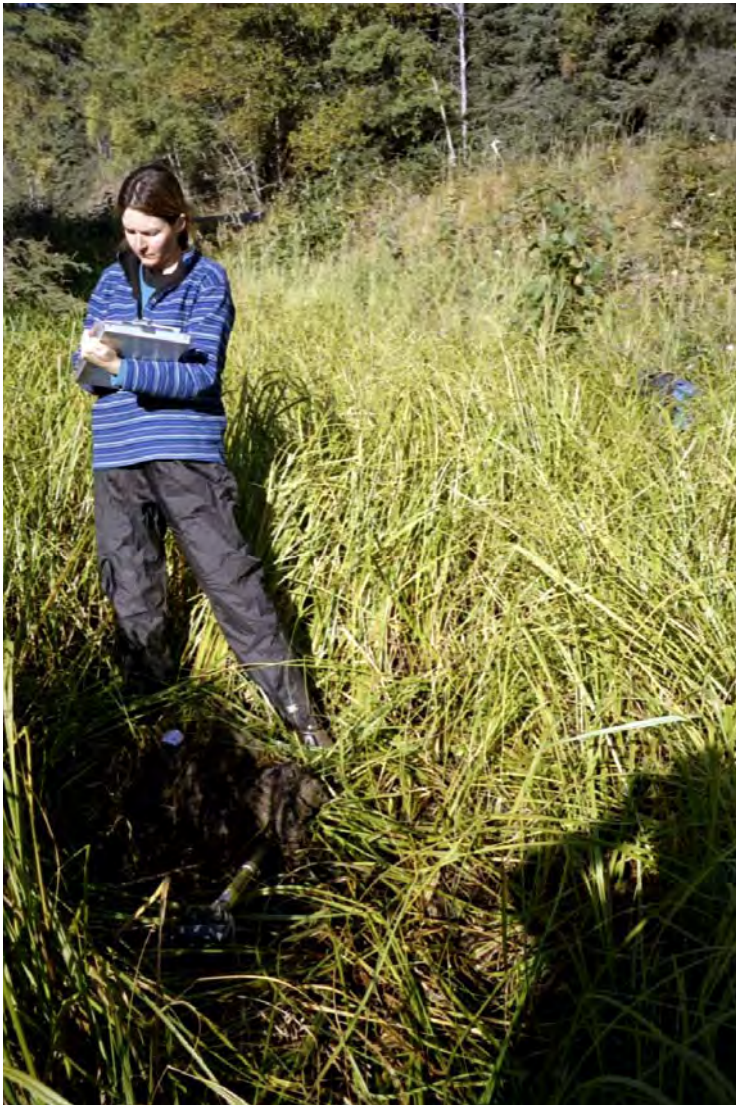
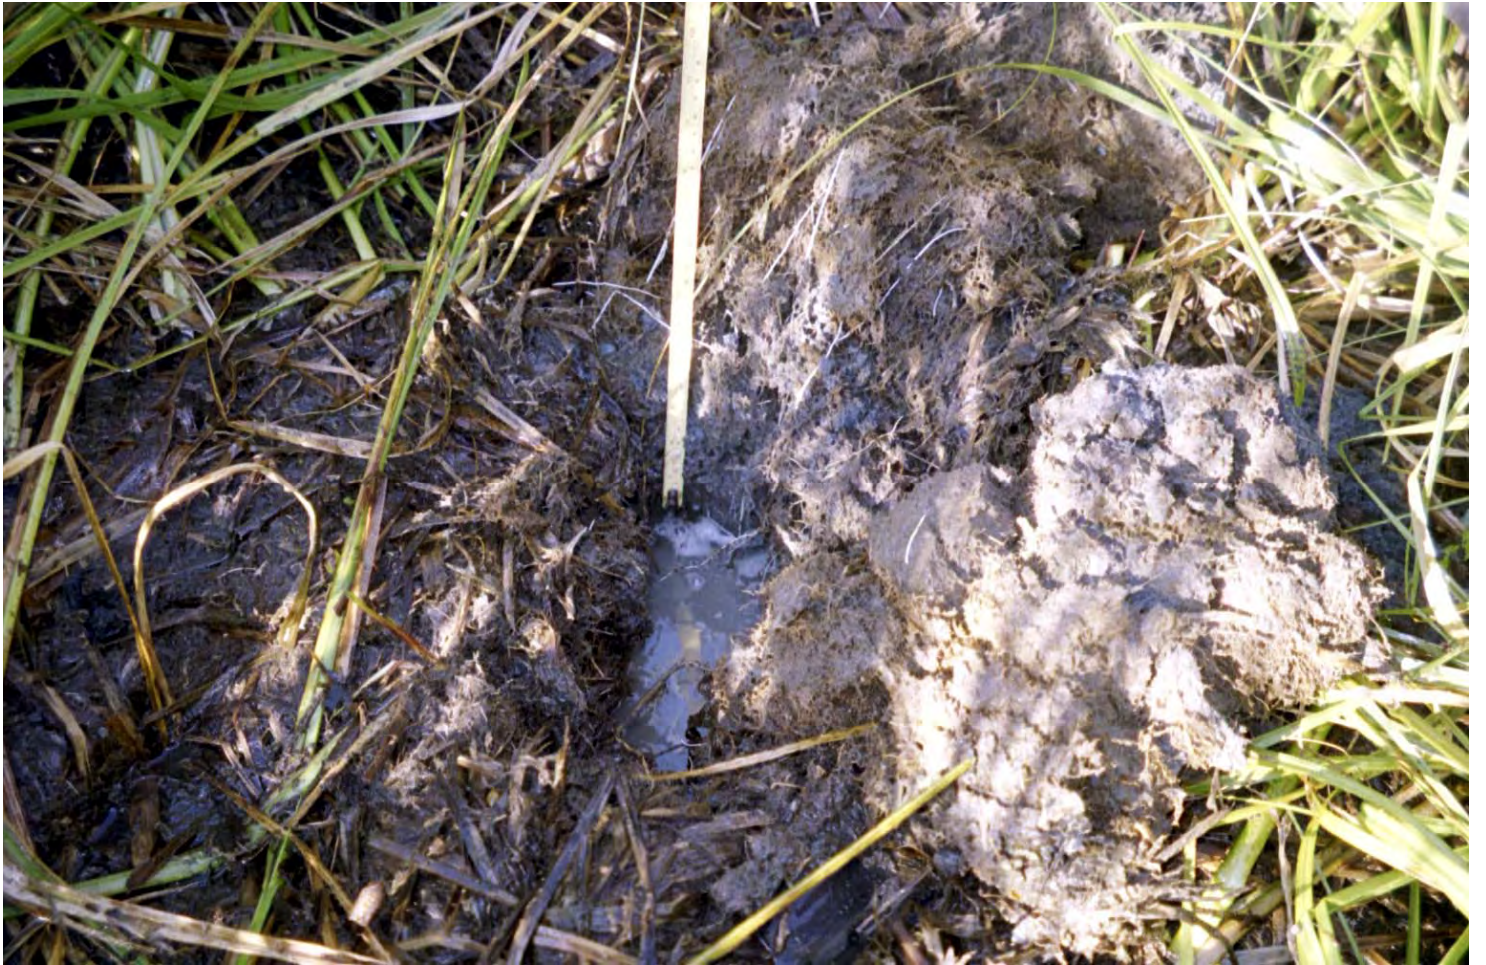
There is a small area of upland forest adjacent to pond 2. There is an alder, cal can fringe, and open water.

Describe Vegetation Type: sedge meadow

Hydrophytic Vegetation Present?	<input checked="" type="checkbox"/> YES <input type="checkbox"/> NO	Is this Sampling Point Within a Wetland? <input checked="" type="checkbox"/> YES <input type="checkbox"/> NO
Wetland Hydrology Present?	<input checked="" type="checkbox"/> YES <input type="checkbox"/> NO	
Hydric Soils Present?	<input checked="" type="checkbox"/> YES <input type="checkbox"/> NO	
Remarks:		
GPS: Trimble plot 22 Topography: flat NWI Class: PEM1C HGM Type: pond fringe Photos: yes Functions: see form

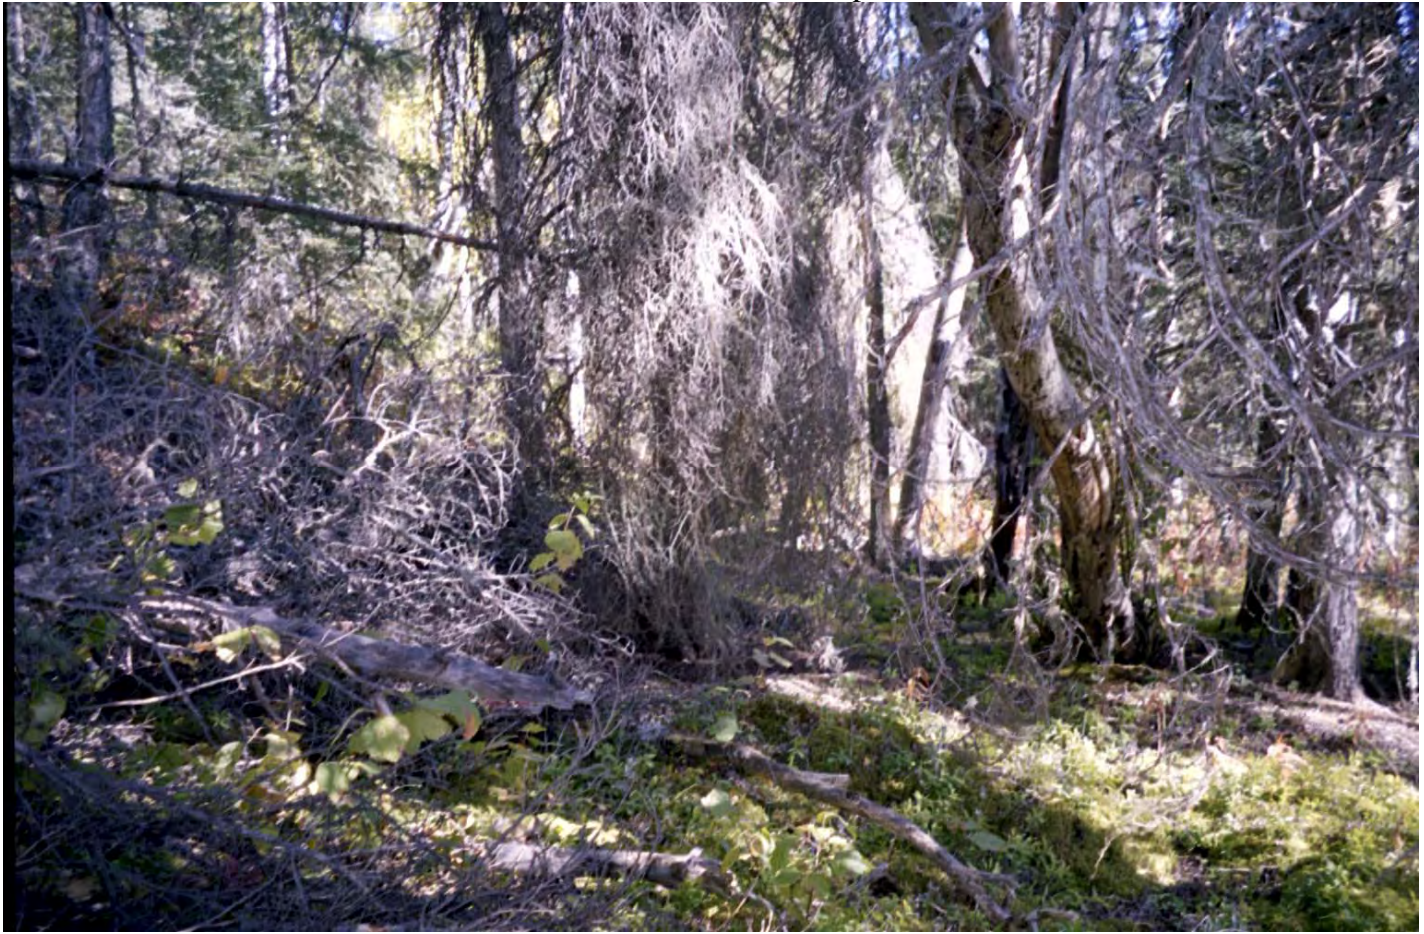
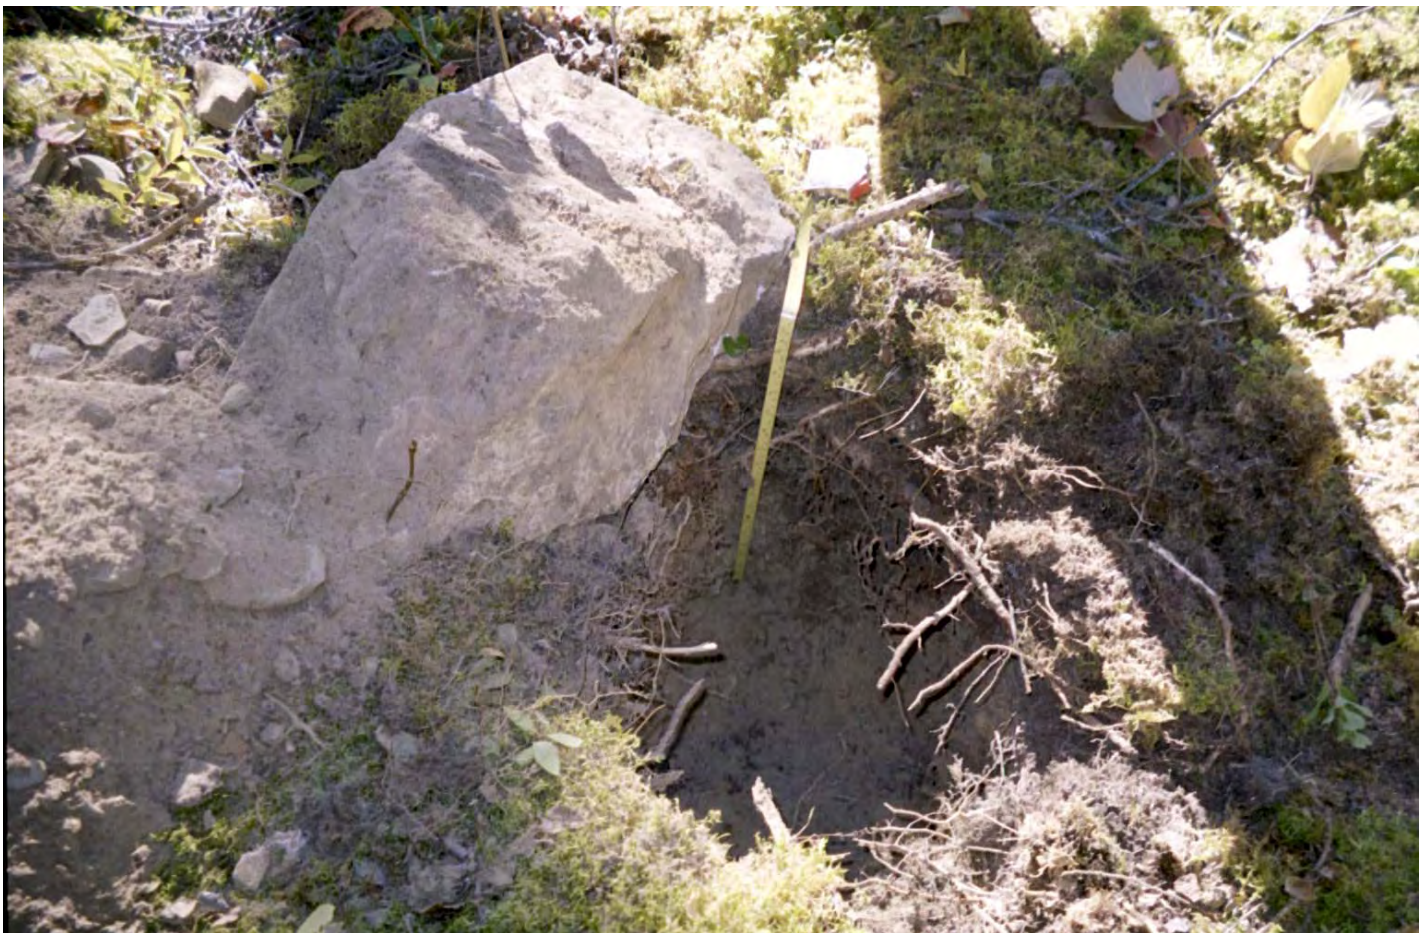
Remarks : Several beetled-killed spruce in plot.  
\* Indicates dominants using 50/20 method.

Describe Vegetation Type: Open spruce, aspen forest.

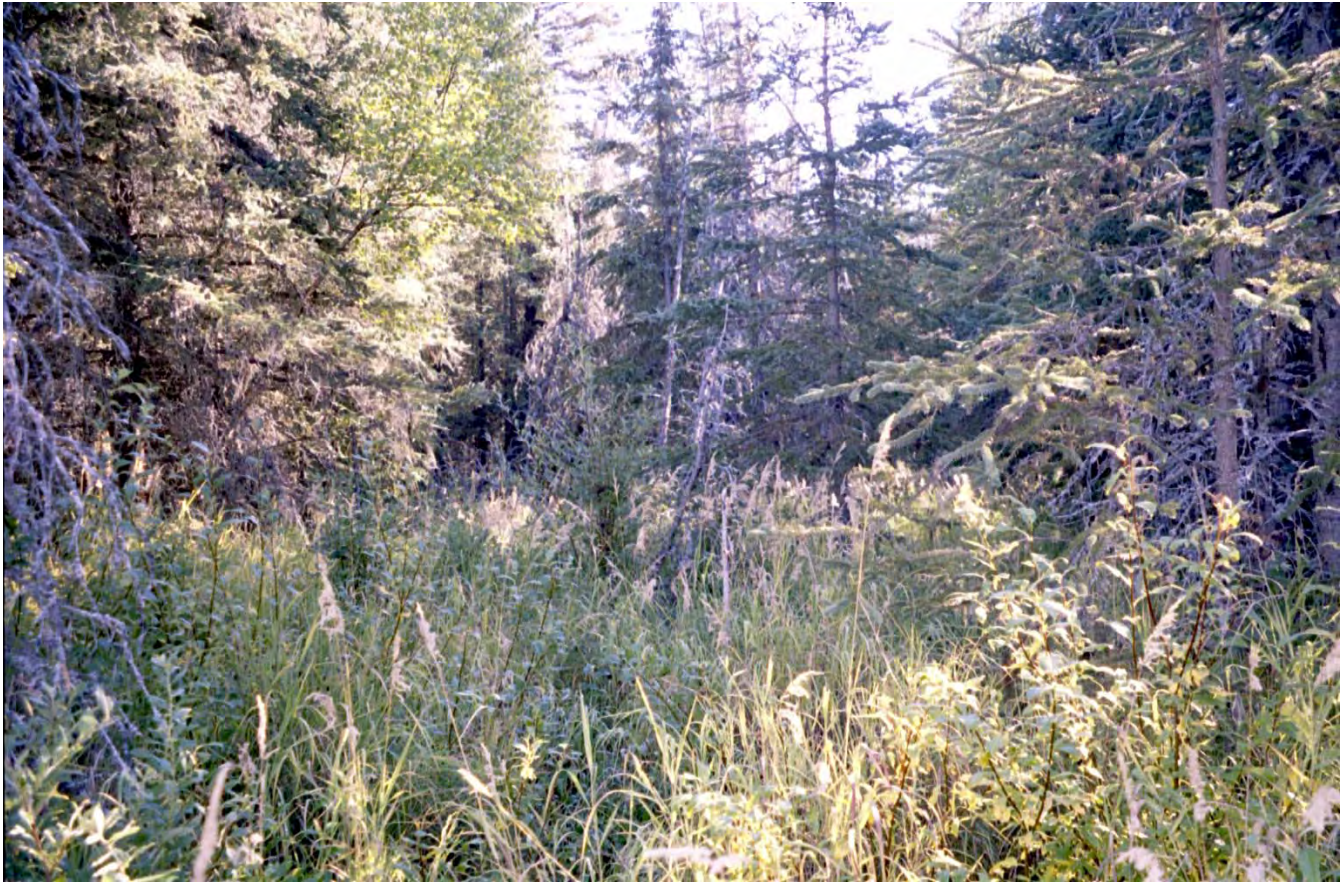
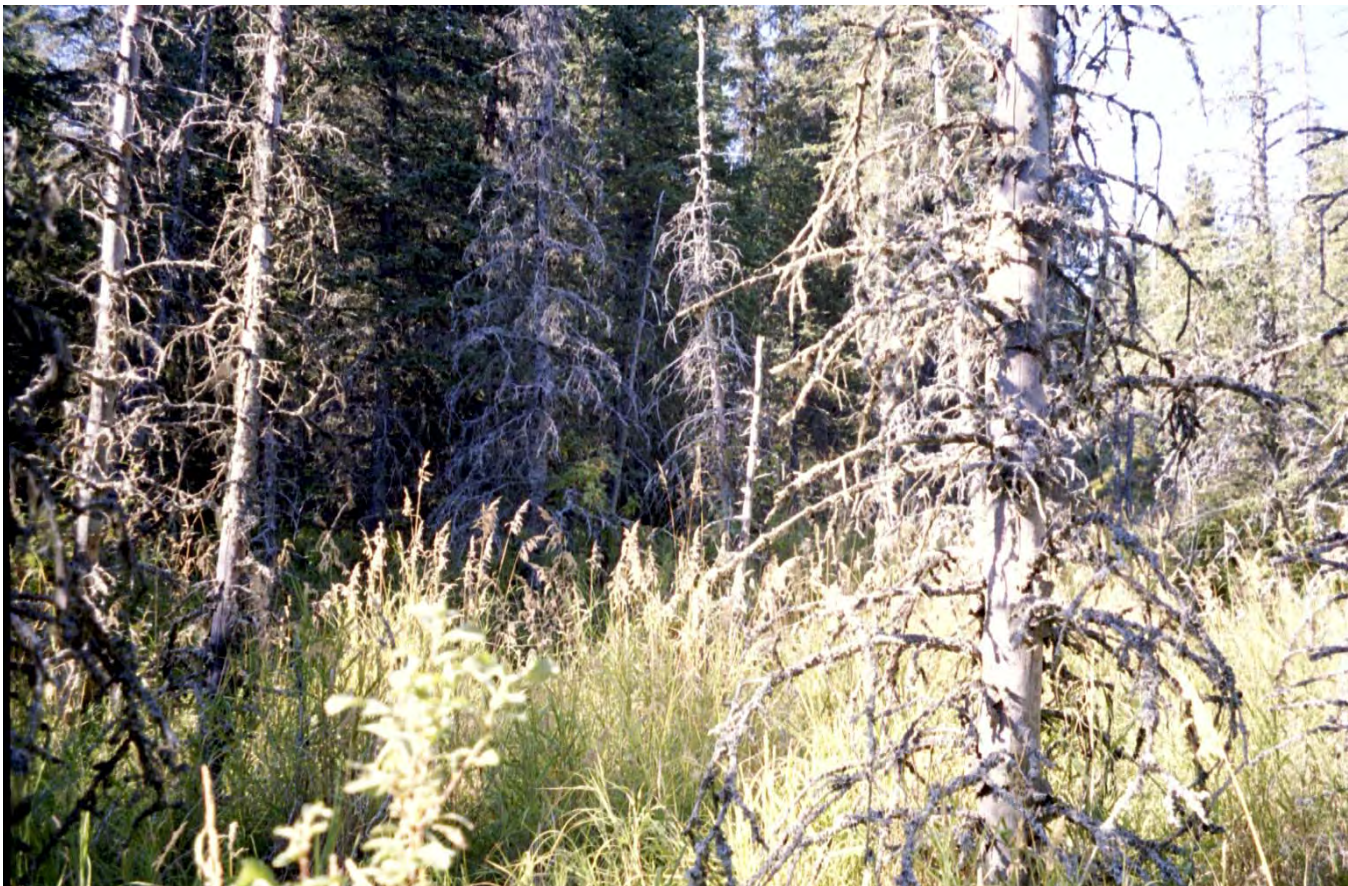
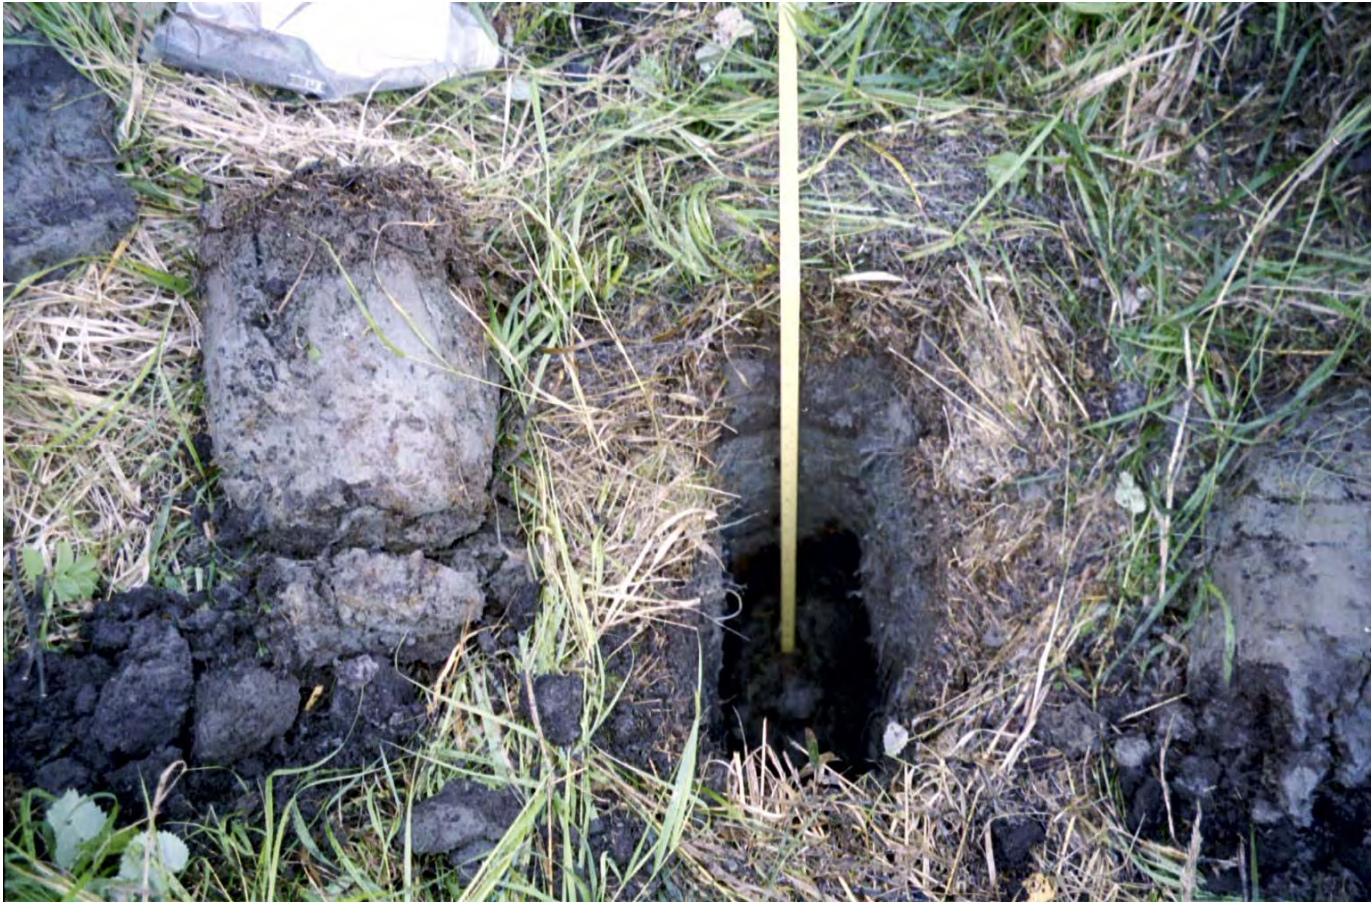
Remarks : Several dead spruce in plot  
\* Indicates dominants using 50/20 method.  
Surrounding areas have more willow.

Describe Vegetation Type: open willow, grassland

Remarks: Several small, dry drainages in plot.

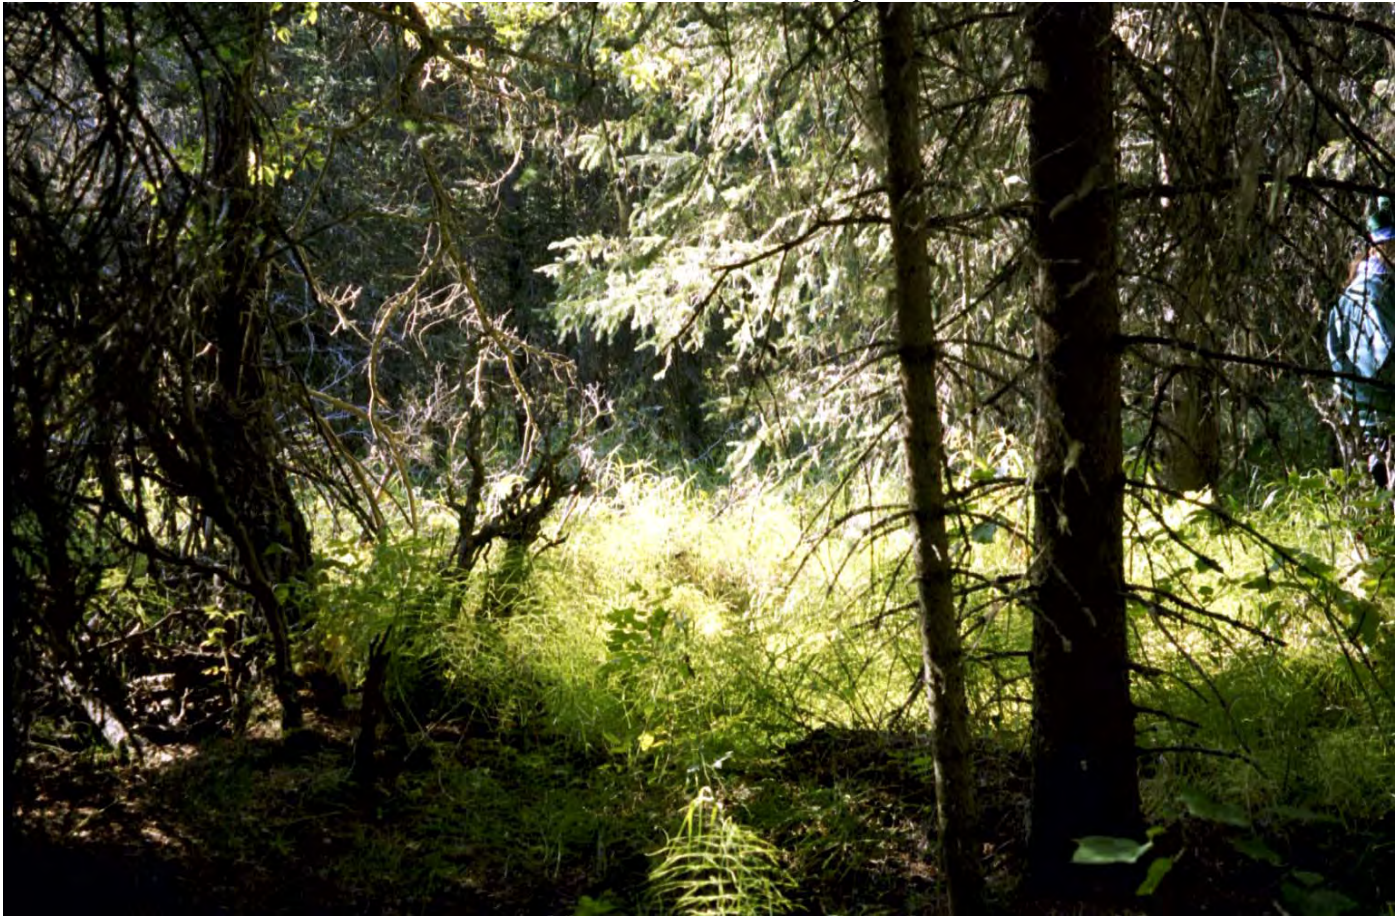
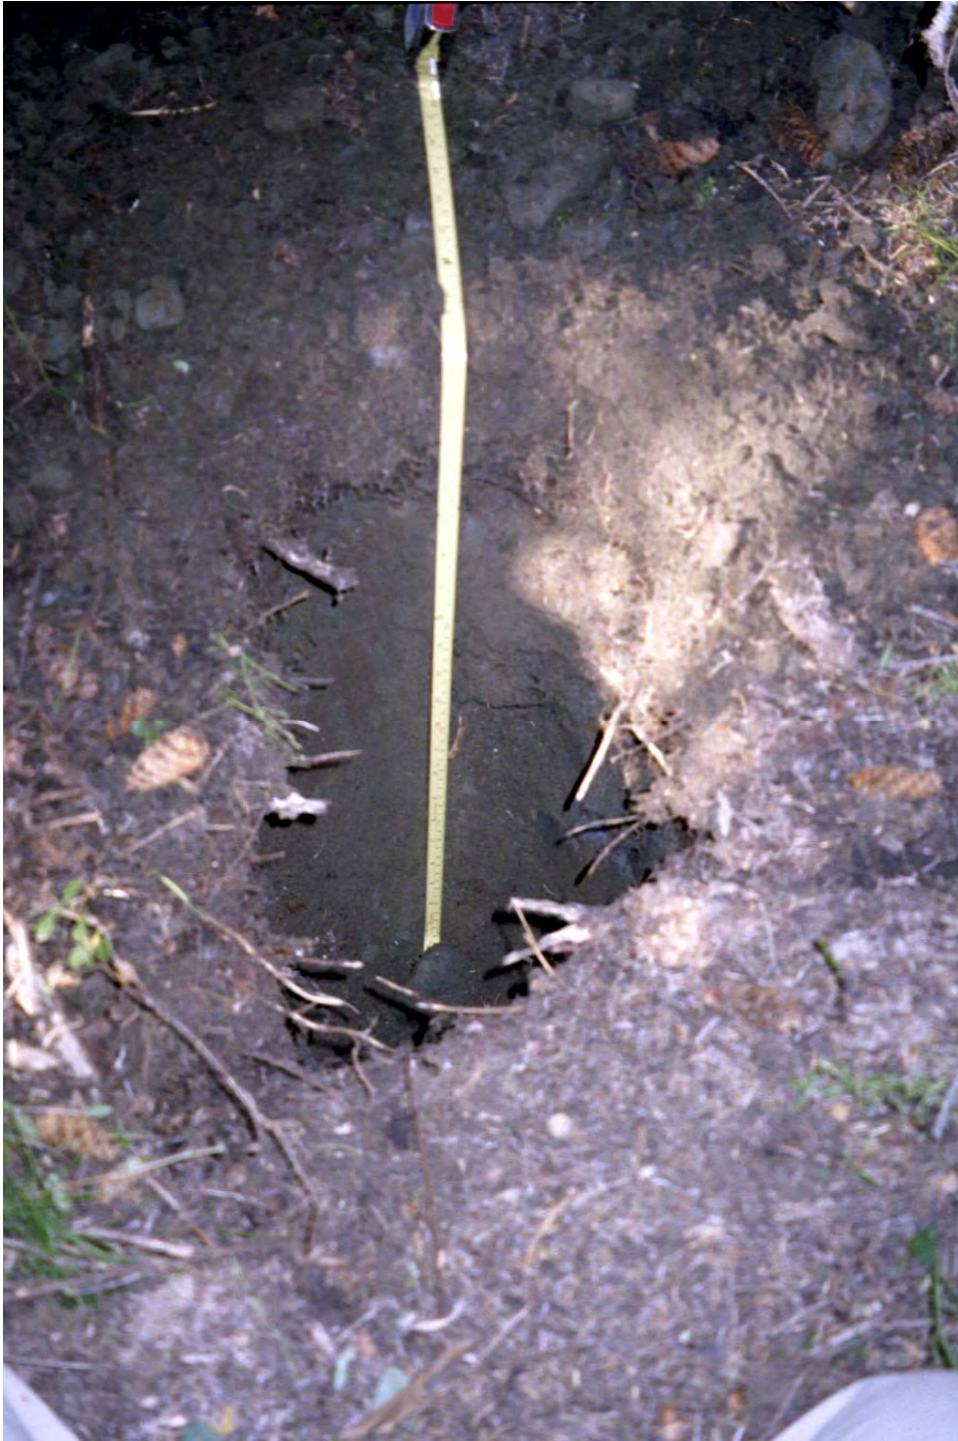
Remarks : Many dead spruce trees in plot – beetle kill.  
\* Indicates dominants using 50/20 method.

Describe Vegetation Type: Lutz spruce forest

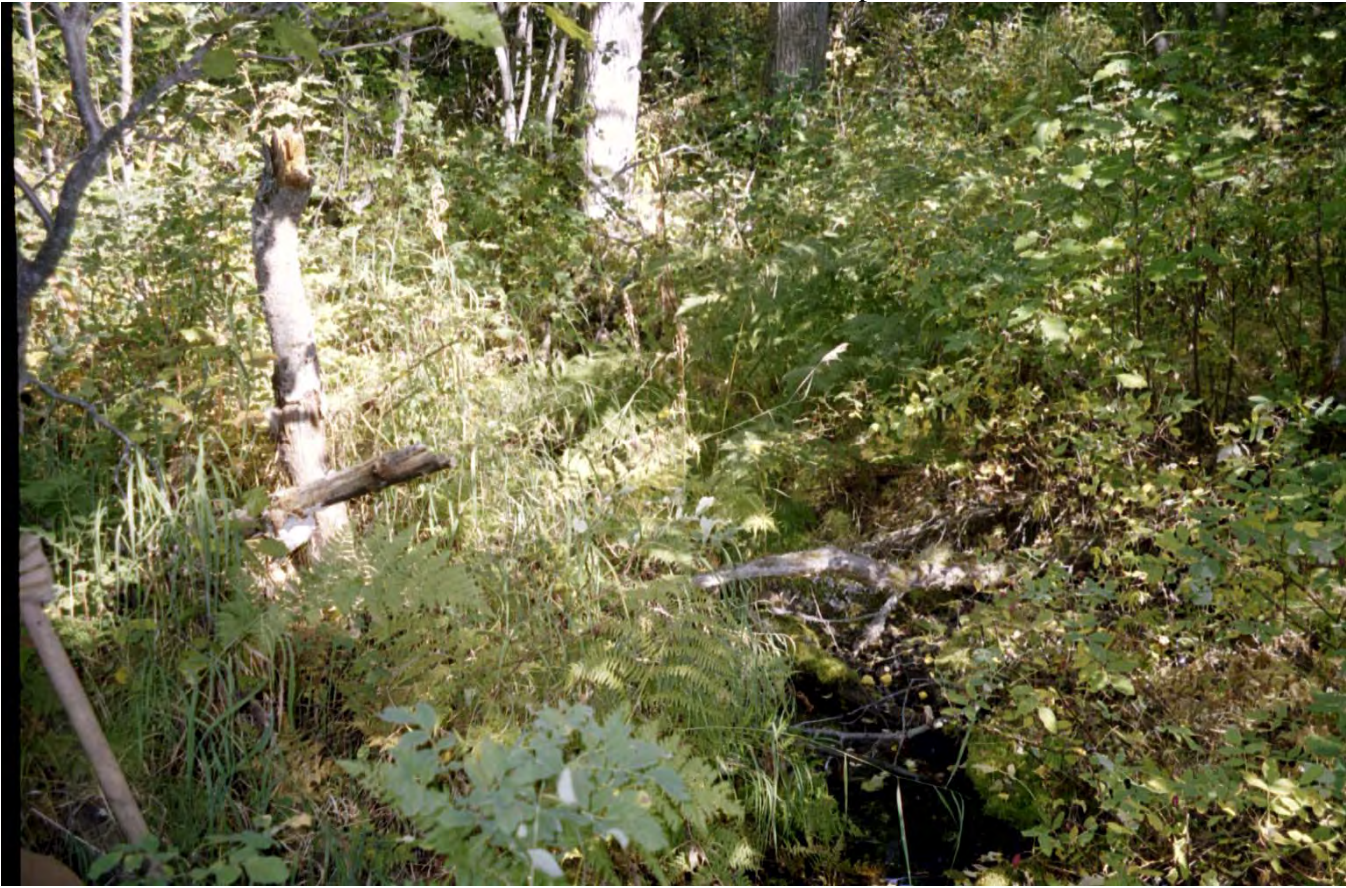
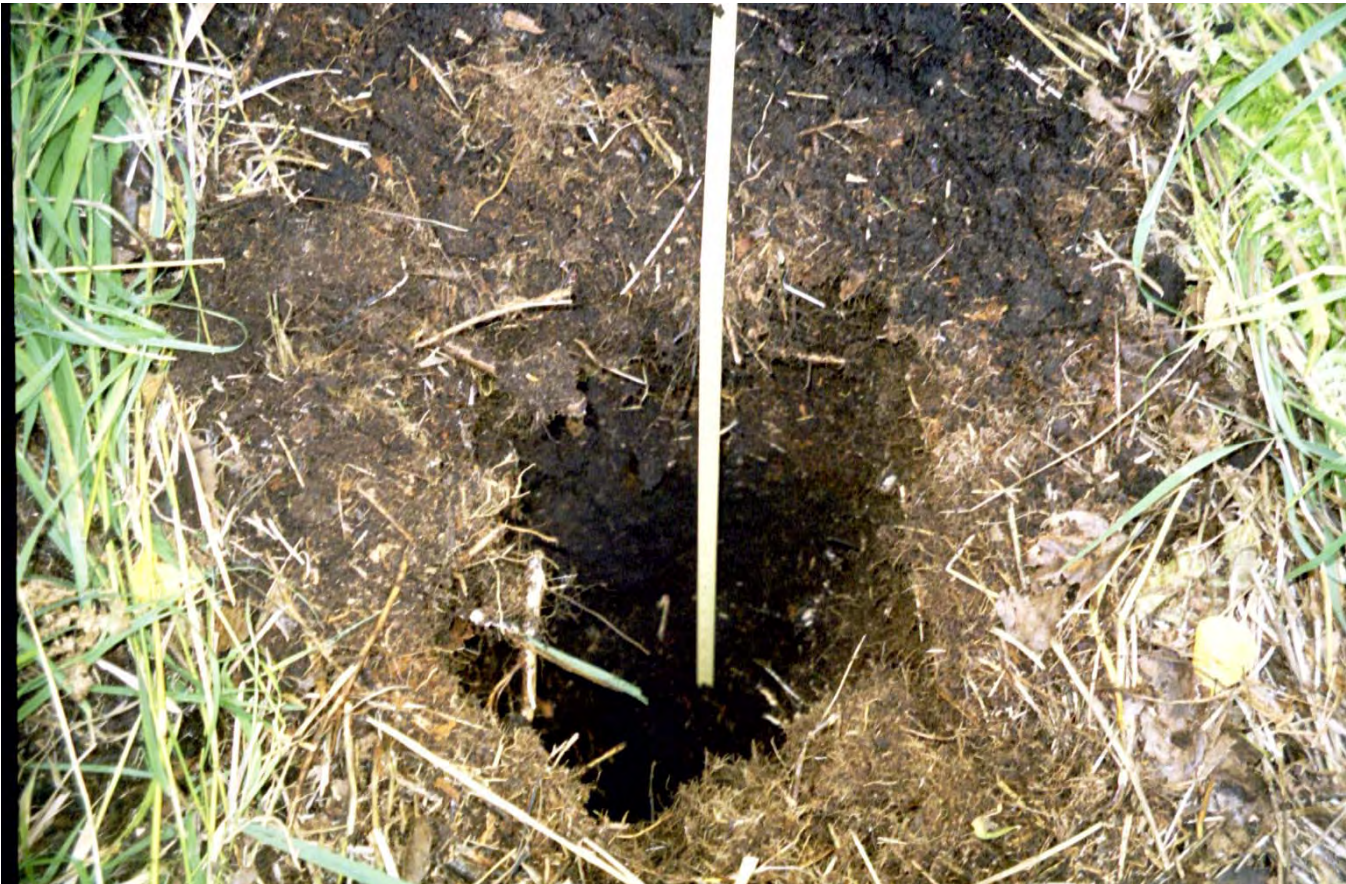
Describe Vegetation Type: alder thicket

Remarks: Creek is 2' from plot.

<input type="checkbox"/> Gleyed or Low-Chroma Colors		<input type="checkbox"/> Other (Explain in Remarks)			
Remarks:					
*Although 20" of organic material is present, it is not saturated and therefore not considered hydric.					
Major root zone: upper 12"
