**ROUTINE WETLAND DETERMINATION  
(1987 COE Wetlands Delineation Manual)**

Project/Site: Sterling Highway Project MP 45 - 60	Date	9-15-03
Applicant / Owner: ADOT&PF	Borough	KPB
Investigators: JDS & AA	State	AK
Do Normal Circumstances exist on the site? <input checked="" type="checkbox"/> YES <input type="checkbox"/> NO	Community ID	Sedge meadow
Is the site significantly disturbed (Atypical Situation)? <input type="checkbox"/> YES <input checked="" type="checkbox"/> NO	Transect ID	-
Is the area a potential Problem Area? (If needed, explain on reverse) <input type="checkbox"/> YES <input checked="" type="checkbox"/> NO	Plot ID	Plot 21

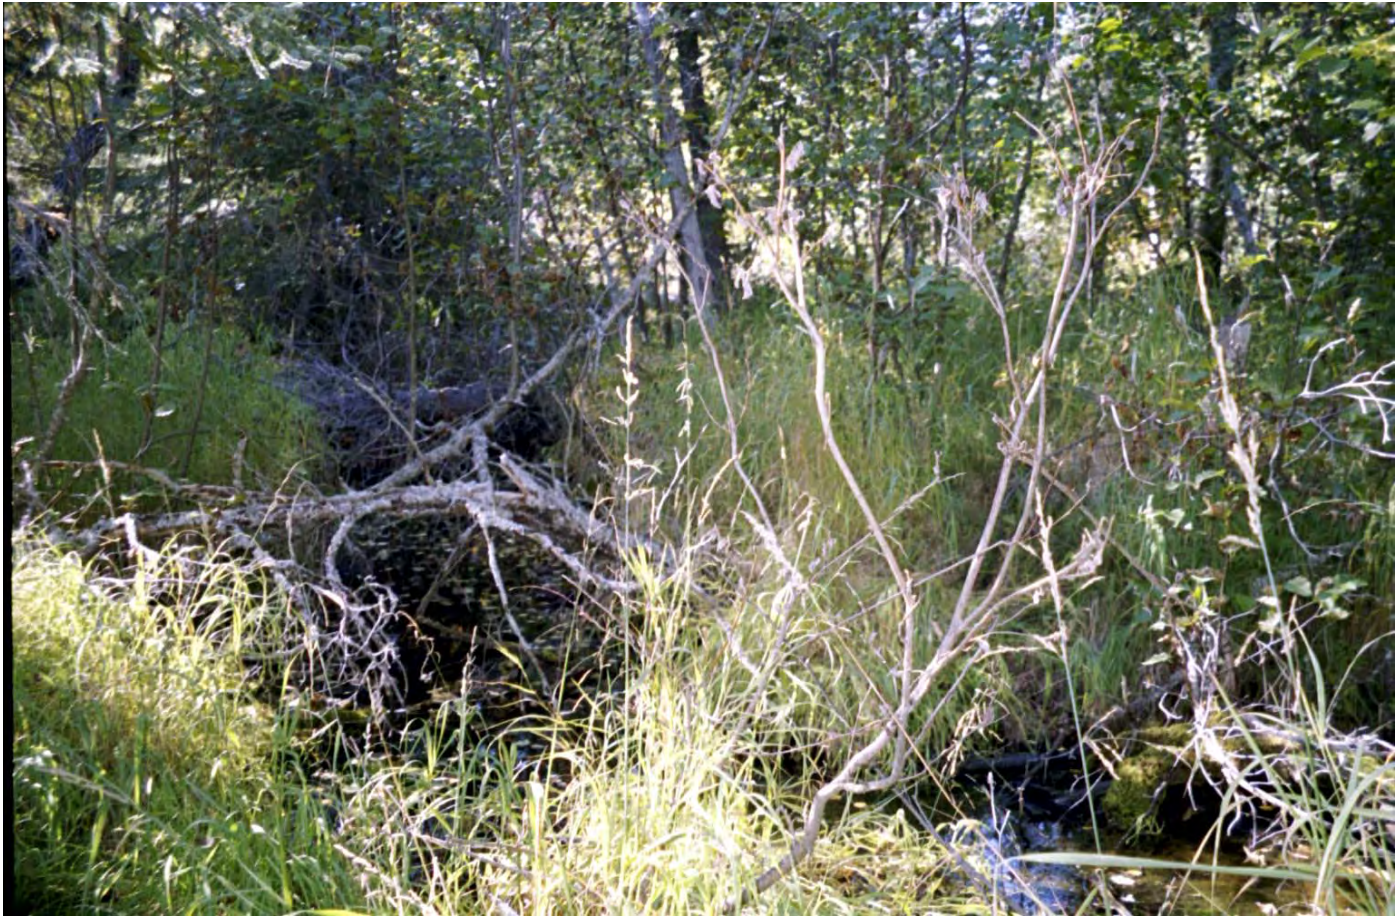
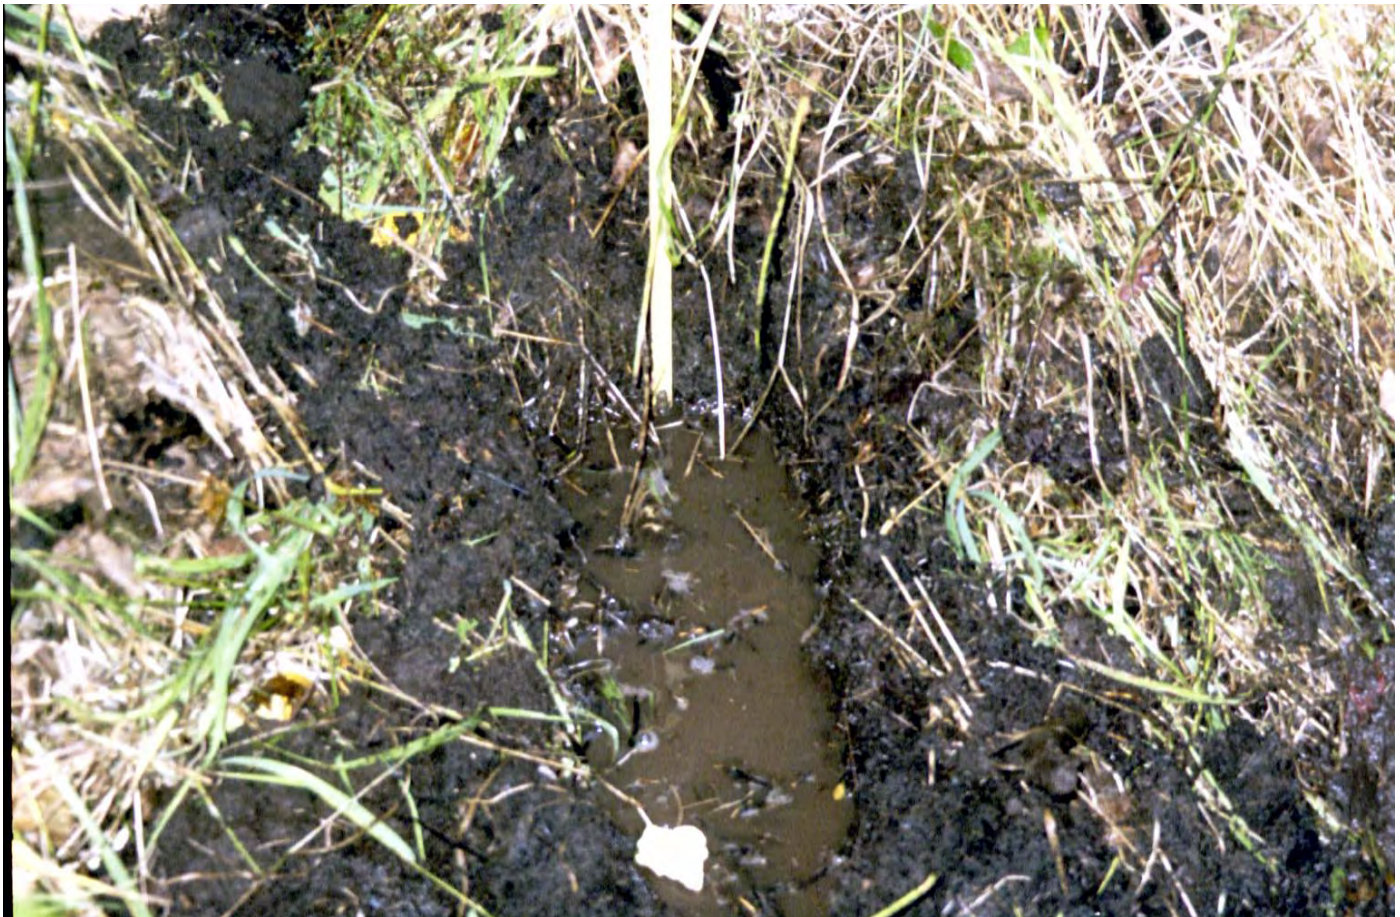
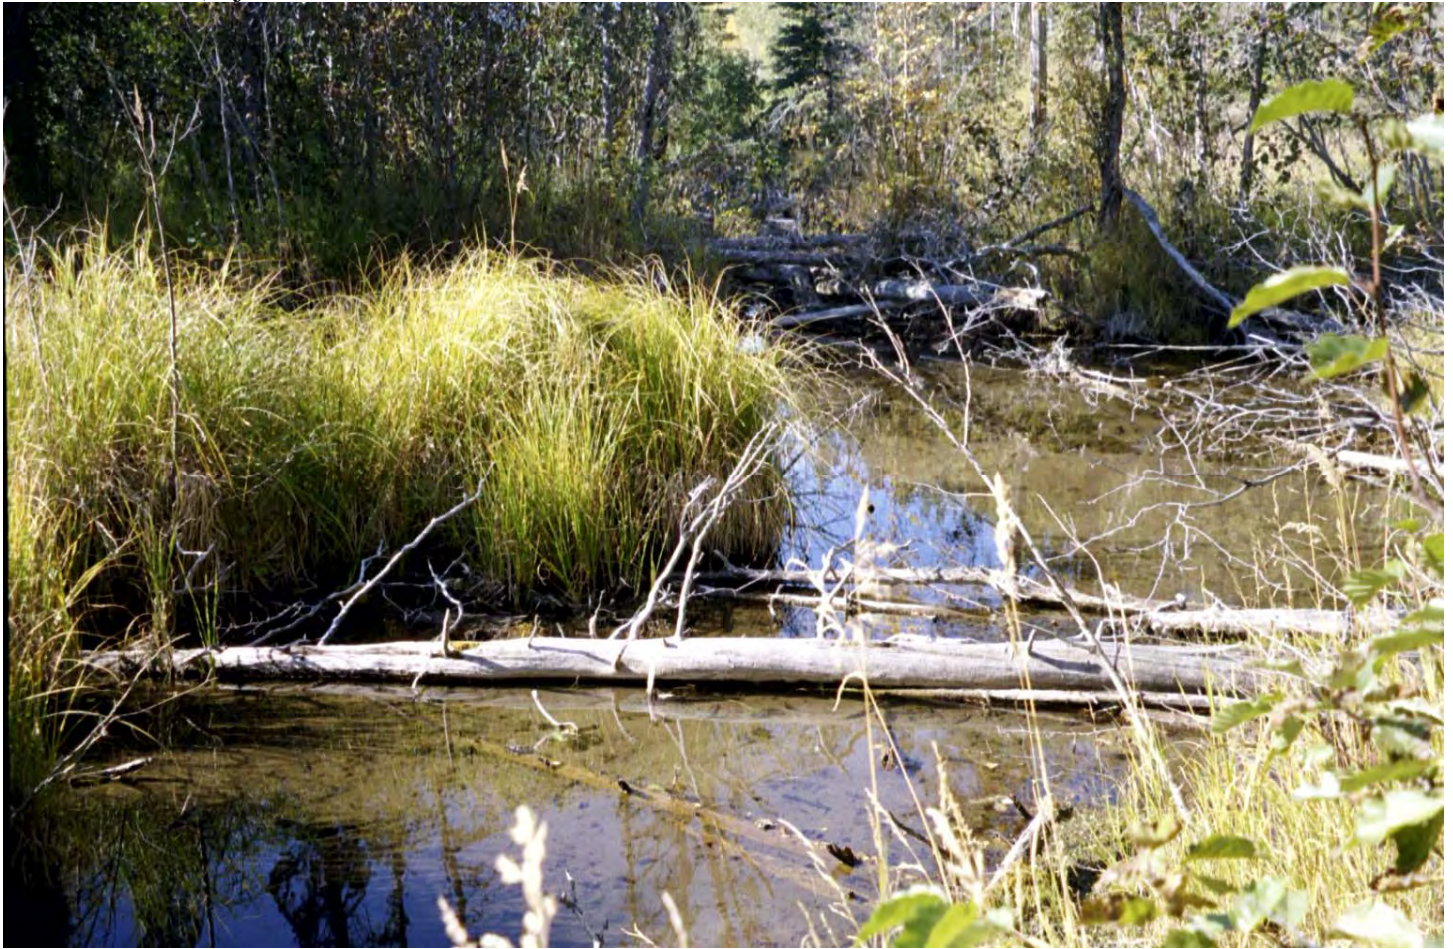
Remarks : Adjacent forest to southeast of plot is upland. Several arms of wetland and standing water are present between forest stands. There is a 50' swath of alder drainage that connects ponds.

Describe Vegetation Type: Alder grass thicket

Remarks: \* An area 2' from pit is inundated. Many areas of standing and flowing water in plot. Adjacent to creek.

<input type="checkbox"/> Gleyed or Low-Chroma Colors		<input type="checkbox"/> Other (Explain in Remarks)			
Remarks: Soil pit is 3 or 4 inches above creek level. At bottom of soil pit there were gravels and rocks.					
Major root zone:

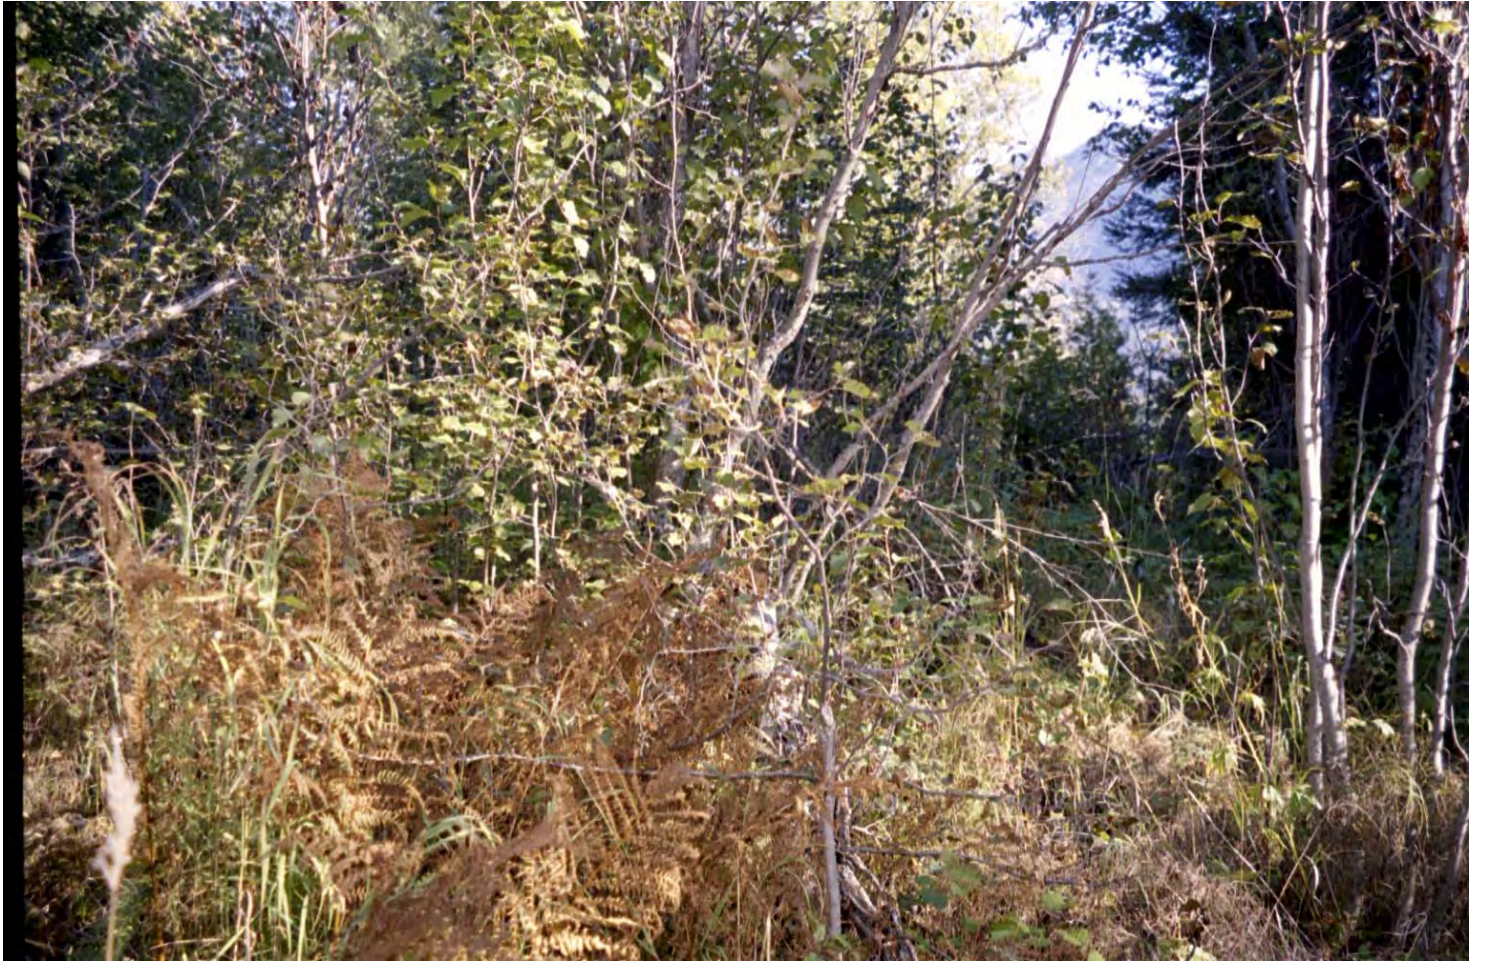
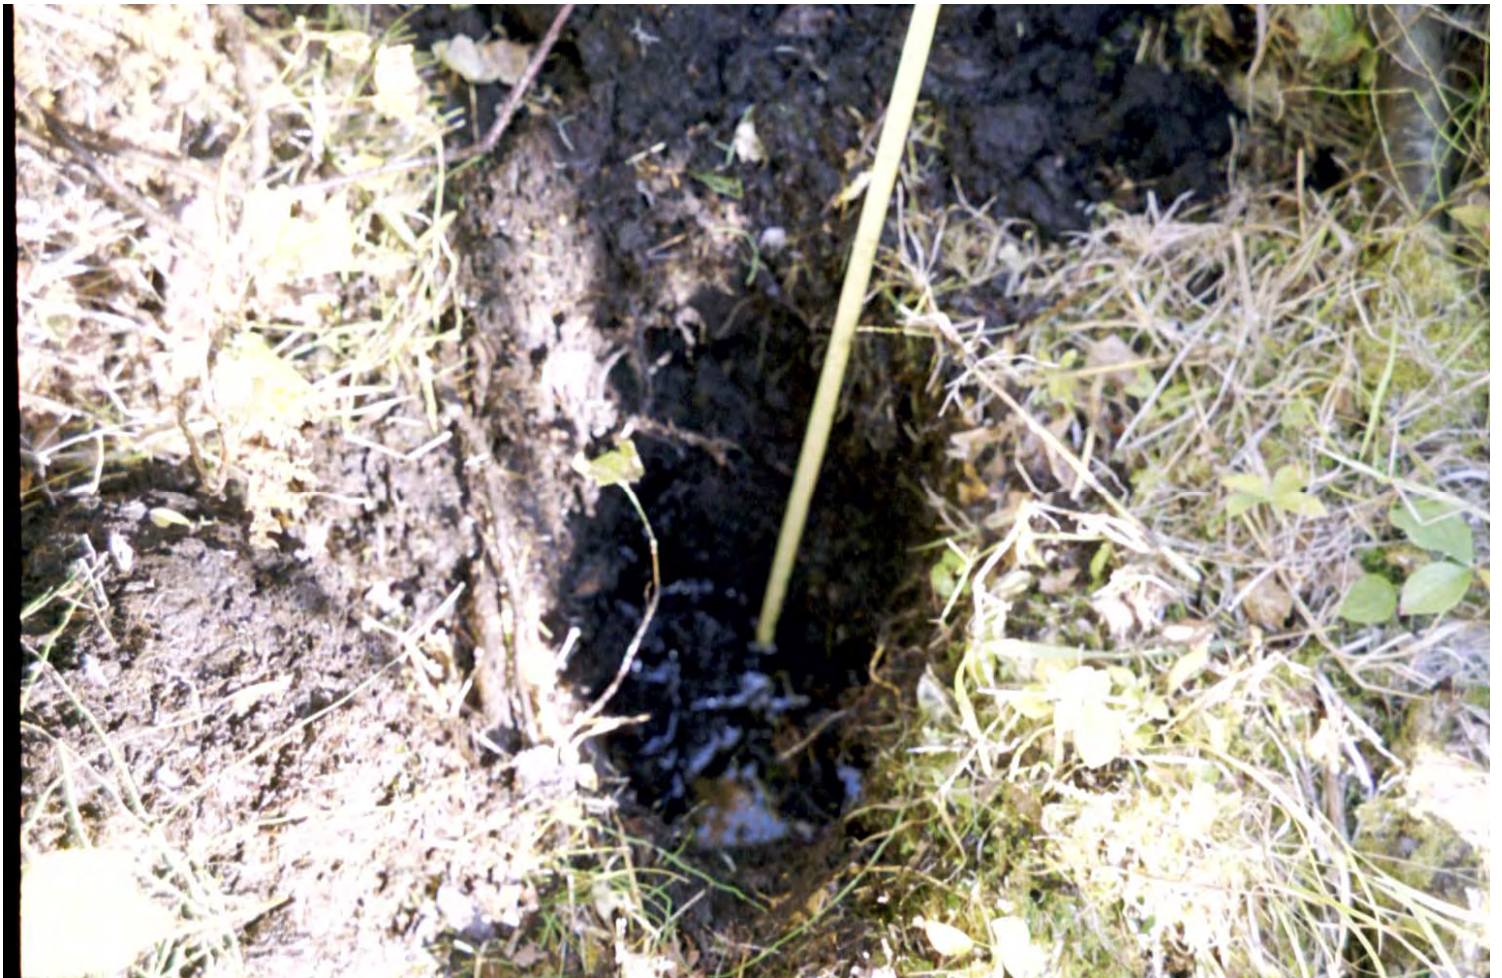
**Describe Location: No waypoint, in opening near creek, creek could connect to plot 27.**

Describe Vegetation Type: Alder thicket near creek

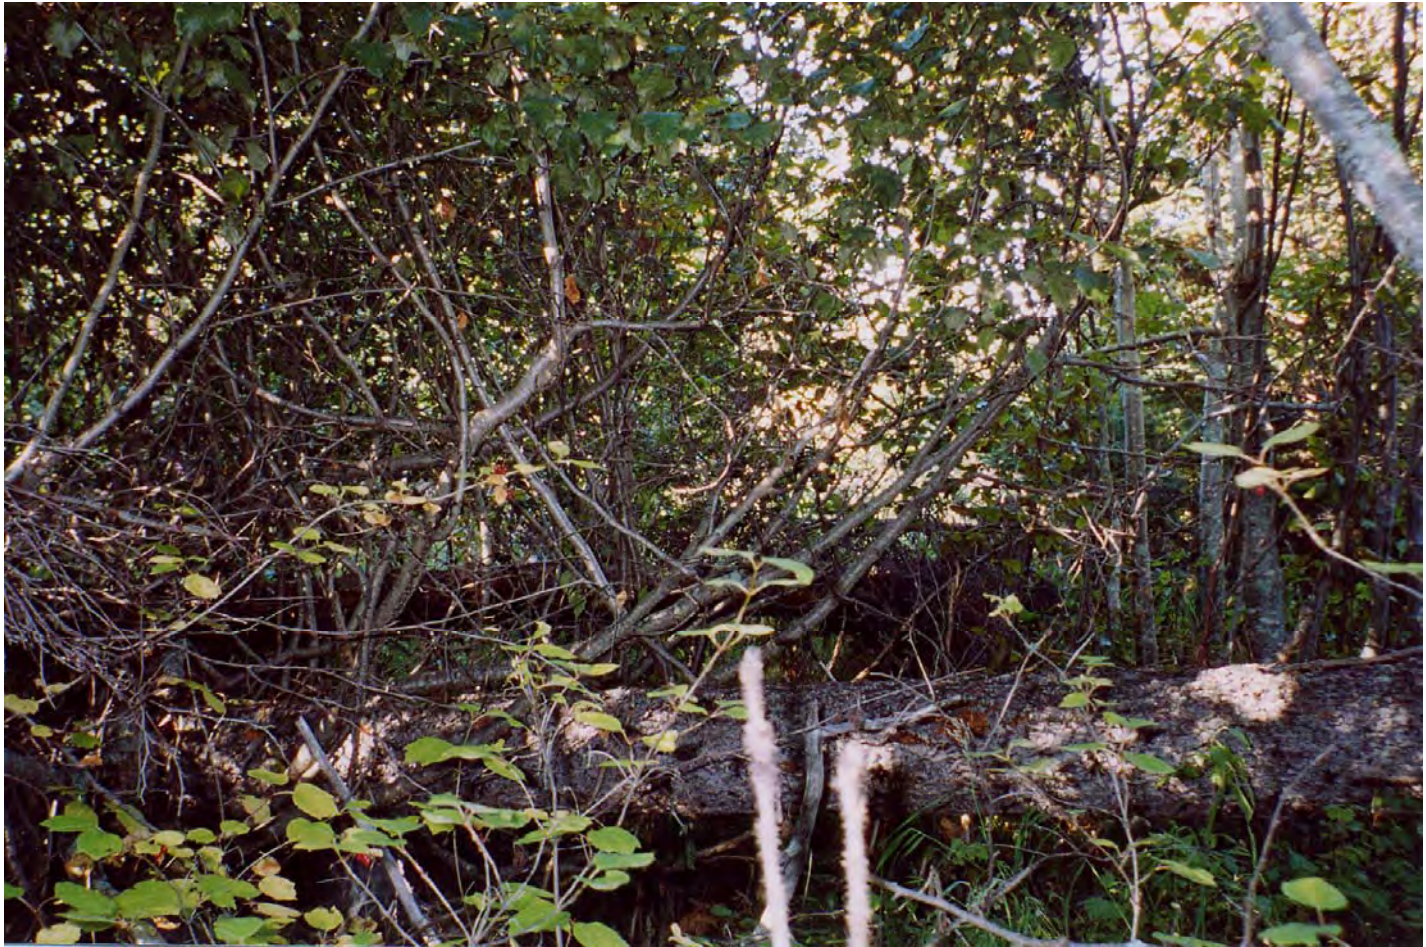
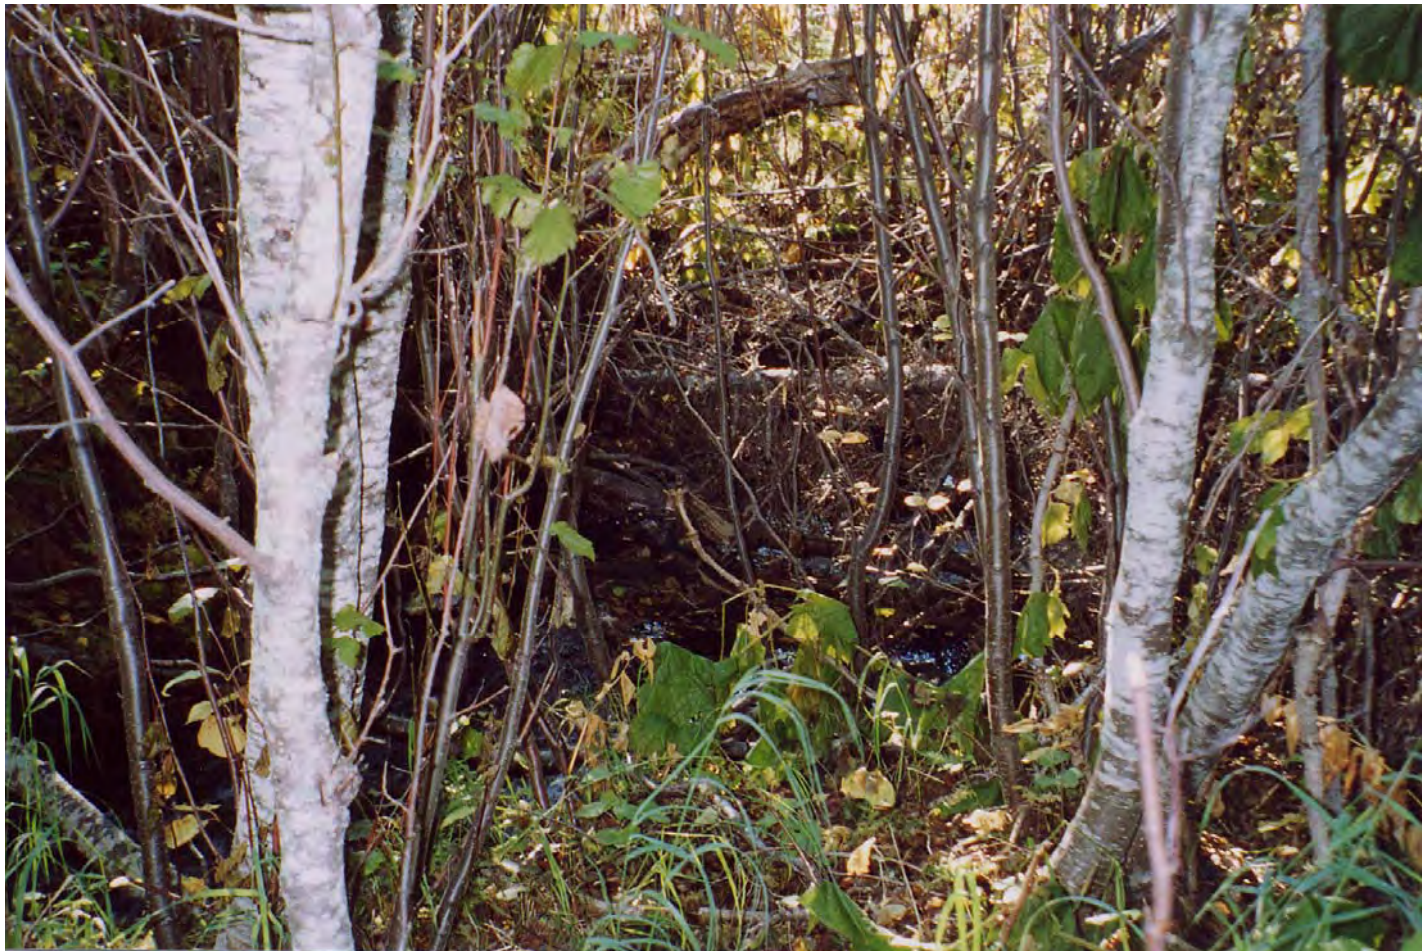
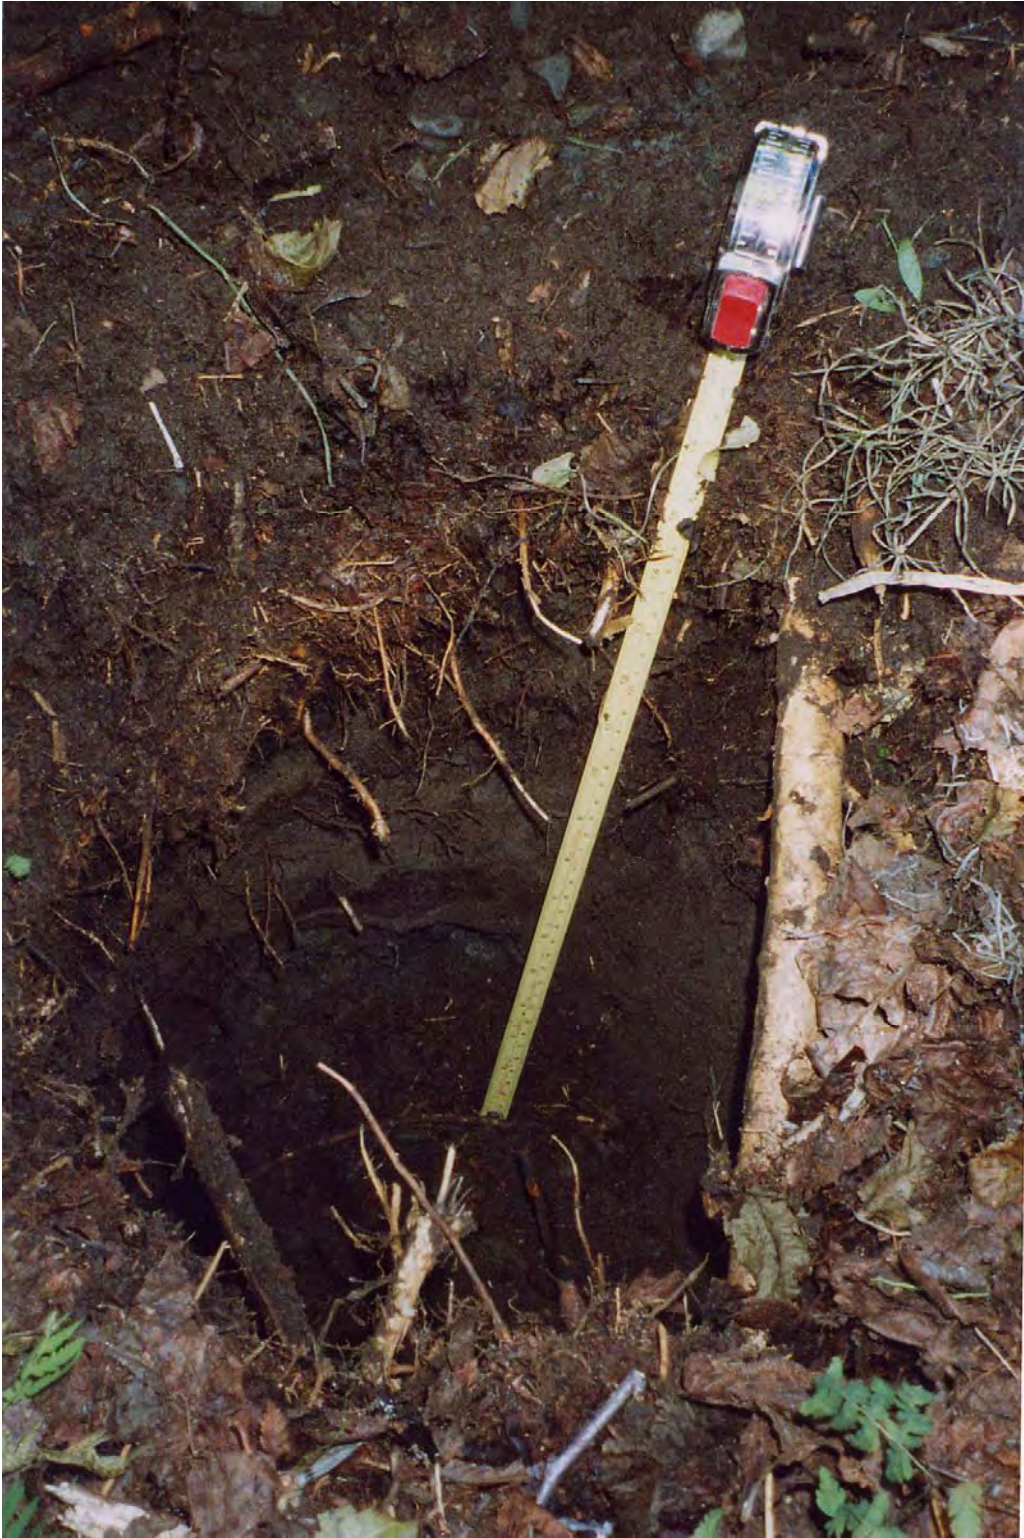
Describe Vegetation Type: Alder thicket

Remarks: Plot is adjacent to stream.

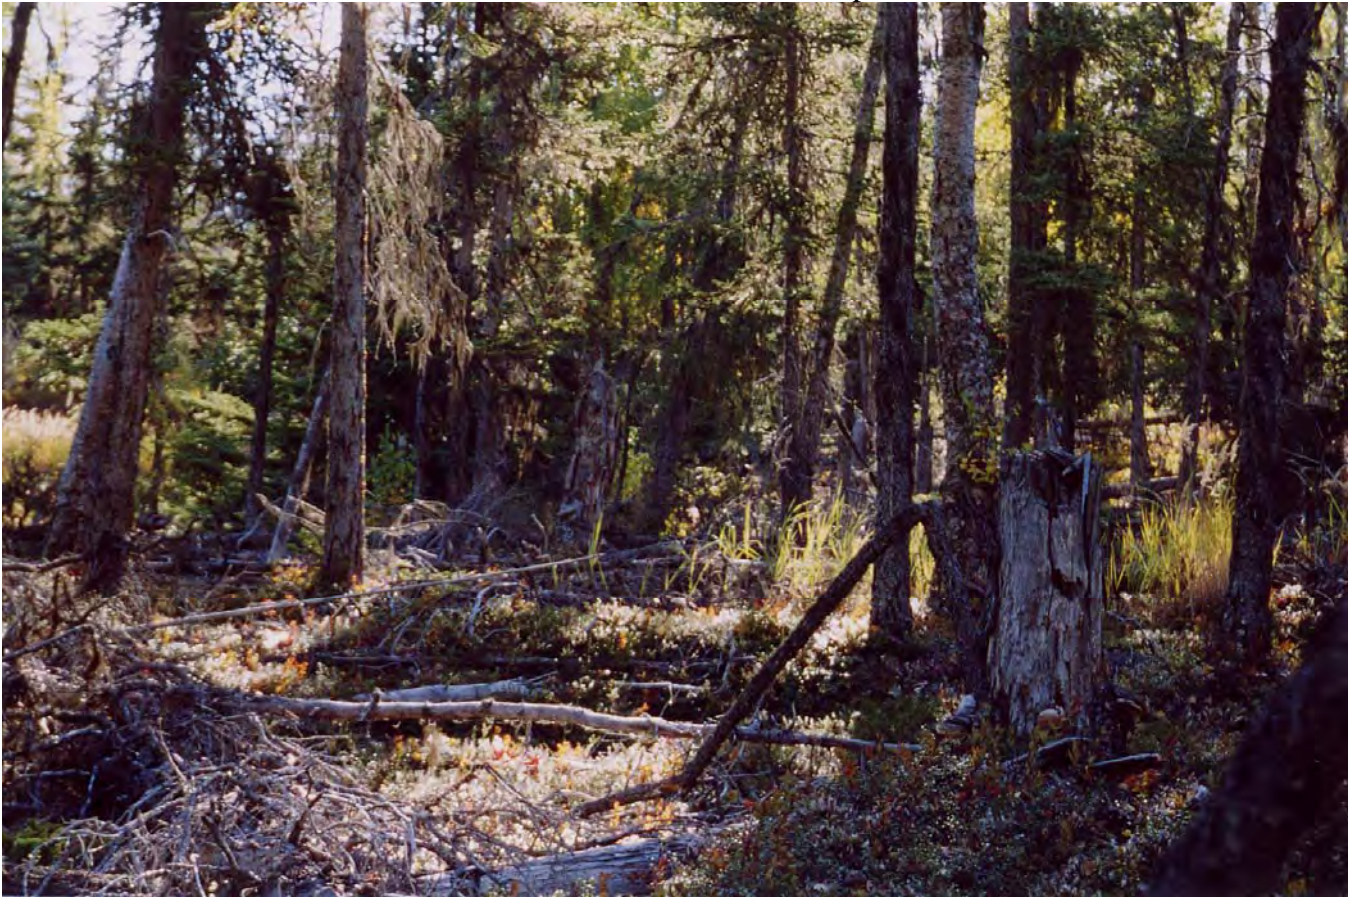
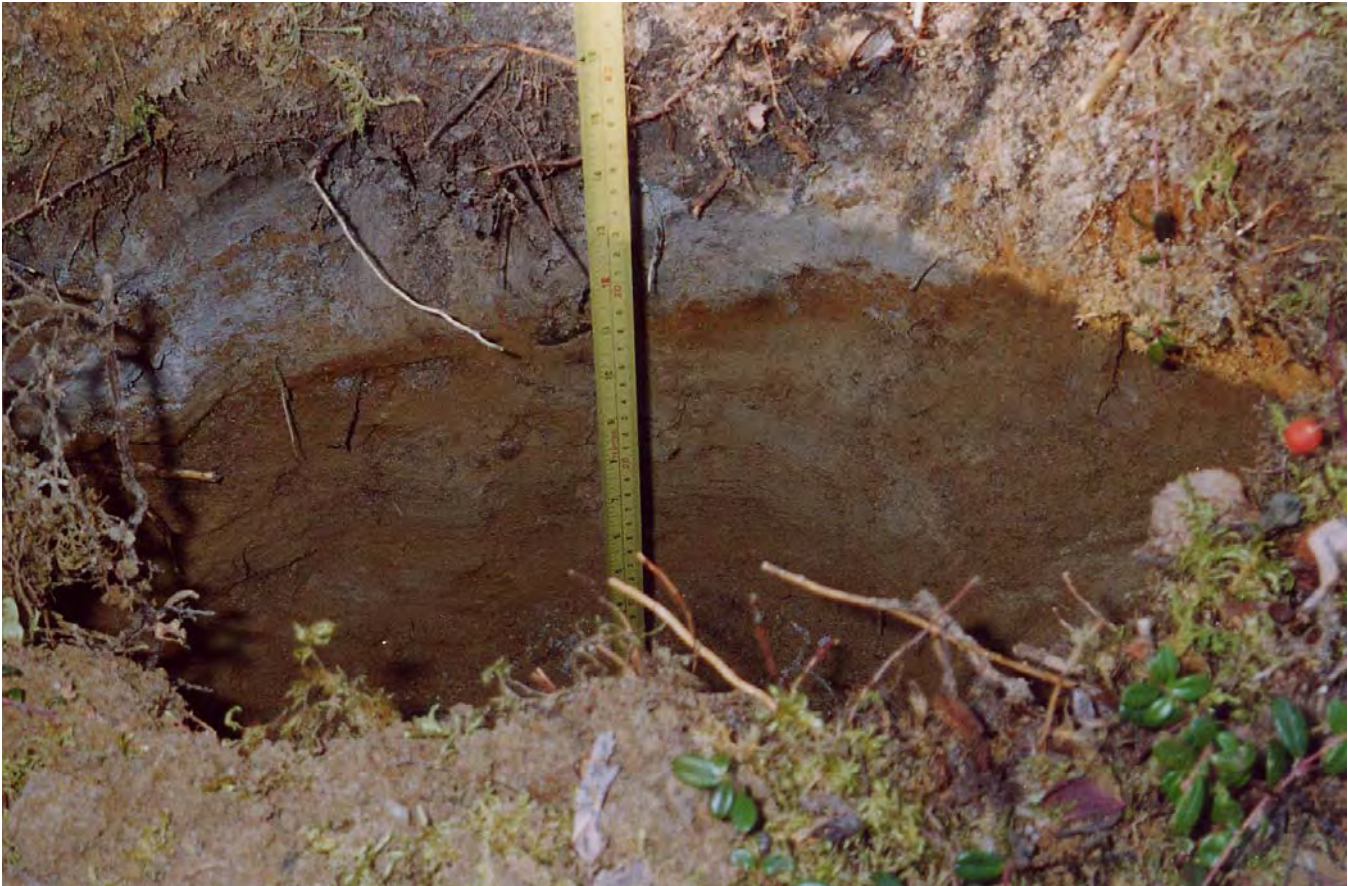
Remarks : Several dead and dying spruce in plot (beetle kill)  
\* Indicates dominants using 50/20 method.

Describe Vegetation Type: Open spruce forest
