Appendix A

Traffic Crash Data Analysis

**State of Alaska
Department of Transportation and
Public Facilities**

Prepared by:
**HDR Alaska, Inc.
2525 C Street, Suite 305
Anchorage, Alaska 99503**

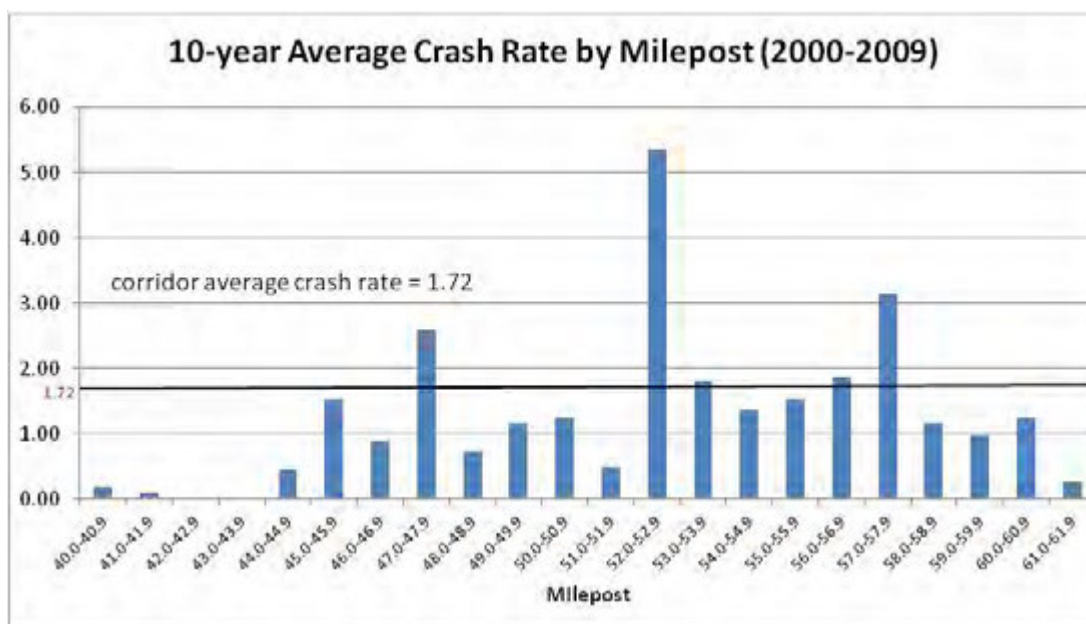
Figure 1. Study Area Crash Rate per Milepost from January 2000 to December 2009

Within the 15-mile Study Area, 303 crashes occurred between January 1, 2000 and December 31, 2009. The average daily traffic (ADT) on the Sterling Highway during that period was 3,220 vehicles per day.¹ Based on this information, the average crash rate for the corridor was determined to be 1.72 CPMVM. For comparison, the statewide average crash rate for rural primary highways is 1.80. Figure 1 illustrates the 10-year Average Crash Rate by Milepost. Note that the crash rates shown by milepost may not be indicative of where problem areas actually exist within the Study Area.

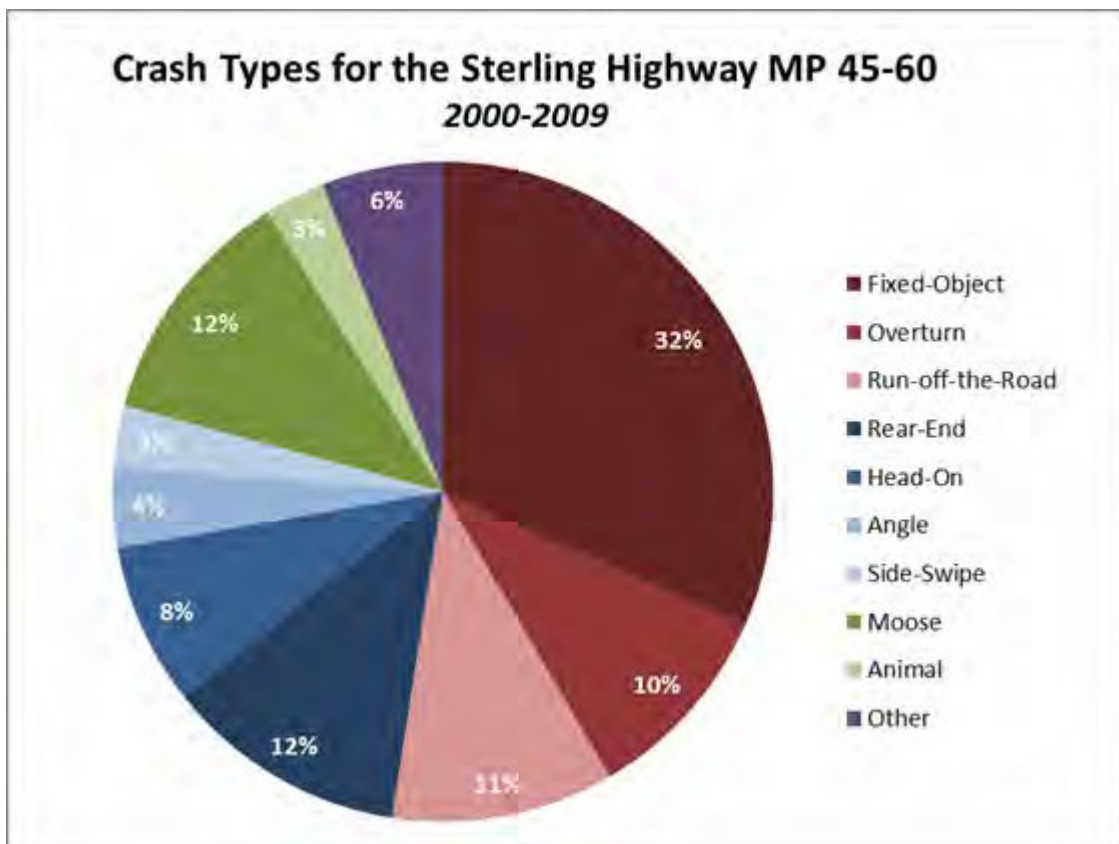
Figure 2. Crash type within the project area between 2000 and 2009

Between 2000 and 2009, there were a wide variety of crash types, such as: run-off-the-road and fixed-object (e.g. ditches, culverts, and embankments) crashes; head-on, rear-end, and angle collisions; and moose-related crashes (Appendix B: Table 2). Figure 2 illustrates the percentages of crash types within the Study Area during our analysis period. Further description of the common crash types is presented below.

Summary: The majority of corridor crashes involved fixed-objects, vehicle overturns, and vehicles running off of the road. Such crashes comprised 53 percent of the total crashes between 2000 and 2009 (Figure 2). Ditches and culverts were two of the most common fixed-objects involved in crashes, with nearly 20 percent of the total crashes in 2009 involving ditches and culverts.

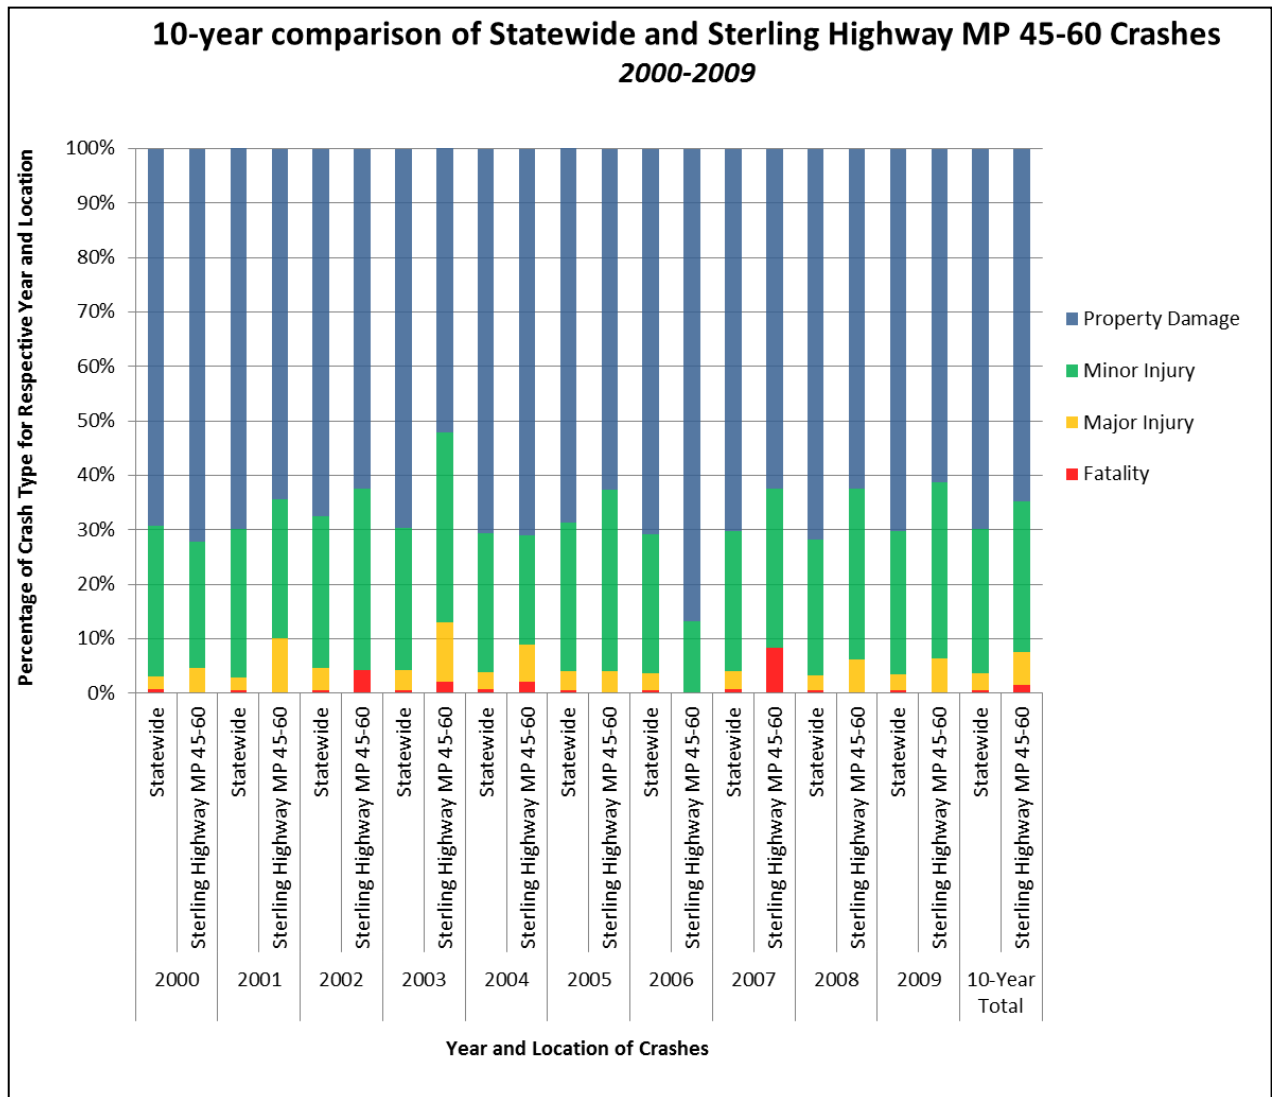
Figure 4. Comparison of the proportional severity of crashes statewide and within the project area

Figure 4 shows that in addition to having more crashes per vehicle mile than the average state roadway, the crashes within the Study Area also tended to be slightly more severe, on average. Excluding the year 2006, MP 45 to 60 of the Sterling Highway had consistently fewer property damage and minor injury (non-incapacitating injury/possible injury) crashes and a higher proportion of major injury (incapacitating injury) and fatality crashes between 2000 and 2009. Also, during four of the ten years shown (2002, 2003, 2004, and 2007) the Study Area had a higher percentage of fatalities than the statewide average (Figure 4).

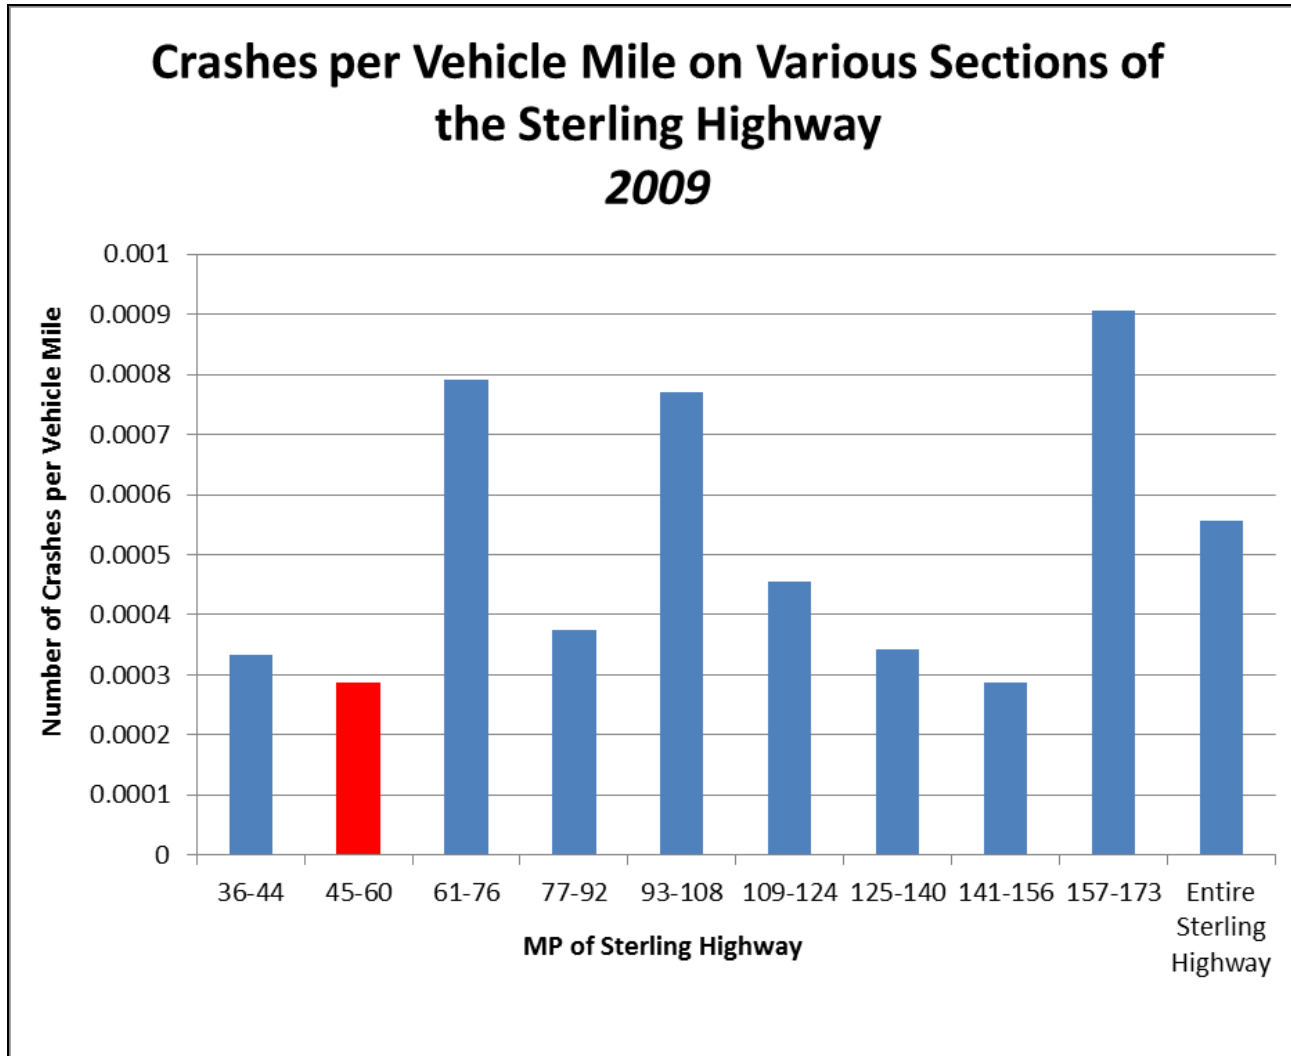
Figure 1. Graph comparing the number of crashes per vehicle mile experienced within different sections of the Sterling Highway in 2009

FIGURE 1 GRAPH COMPARING THE NUMBER OF CRASHES PER VEHICLE MILE EXPERIENCE WITHIN DIFFERENT SECTIONS OF THE STERLING HIGHWAY IN 2009
